INVITATION FOR BIDS
Structural Repairs and Replacement Construction at Cecil Gober
Villas Apartments Units #19-20-21-22

The Housing Authority of the City of Lakeland (herein referred to as "*LHA*") hereby requests bids from licensed and qualified contractors for the repair of fire damage to Units 19, 20, 21, 22 of Cecil Gober Villas Apartments. The repairs must result in the unit being in an *equal to* or *better than* condition than existed prior to the damage. The Scope of Work generated by the insurance adjuster is attached herein as *Exhibit "A"*.

As requested, Jesse W. Curtis, P.E., a FORCON International Corporation (FORCON) Consultant and Professional Civil/Structural Engineer, performed a site investigation and evaluation of reported fire damage at the subject property. The site investigation was performed on June 21, 2021. Mr. Bert McFarlane, representing the insured, provided access to the exterior, interior, and roof of the subject property. The purpose of the investigation was to evaluate the alleged fire damage in the building containing four dwelling units. **FORCON's scope included a structural evaluation of the interior and exterior building to identify building e

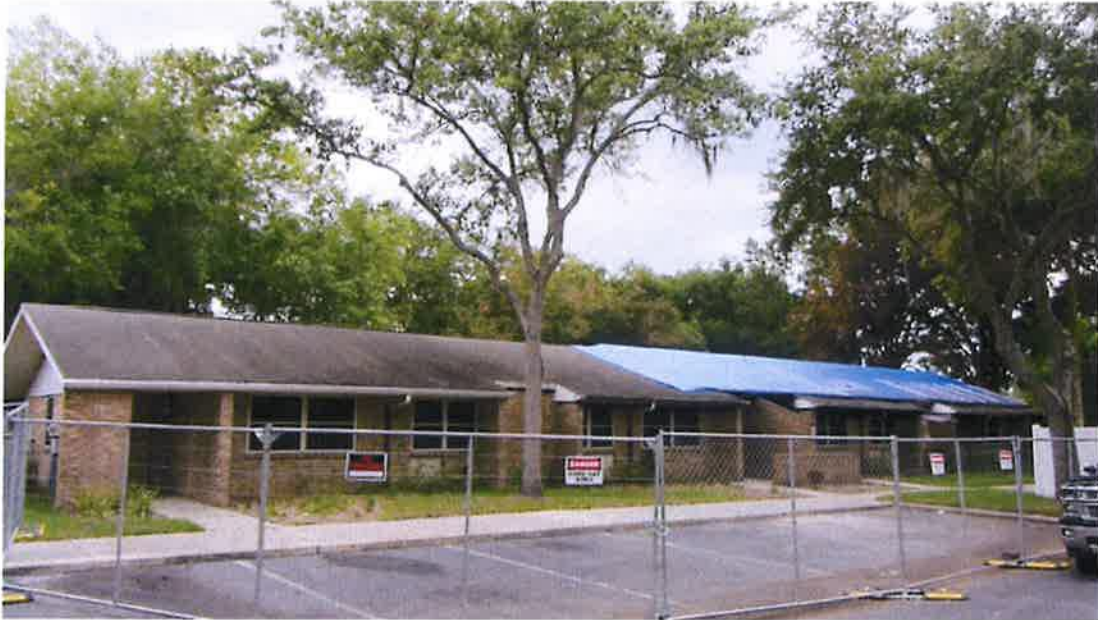
Photograph 1) – Front (east) elevation.

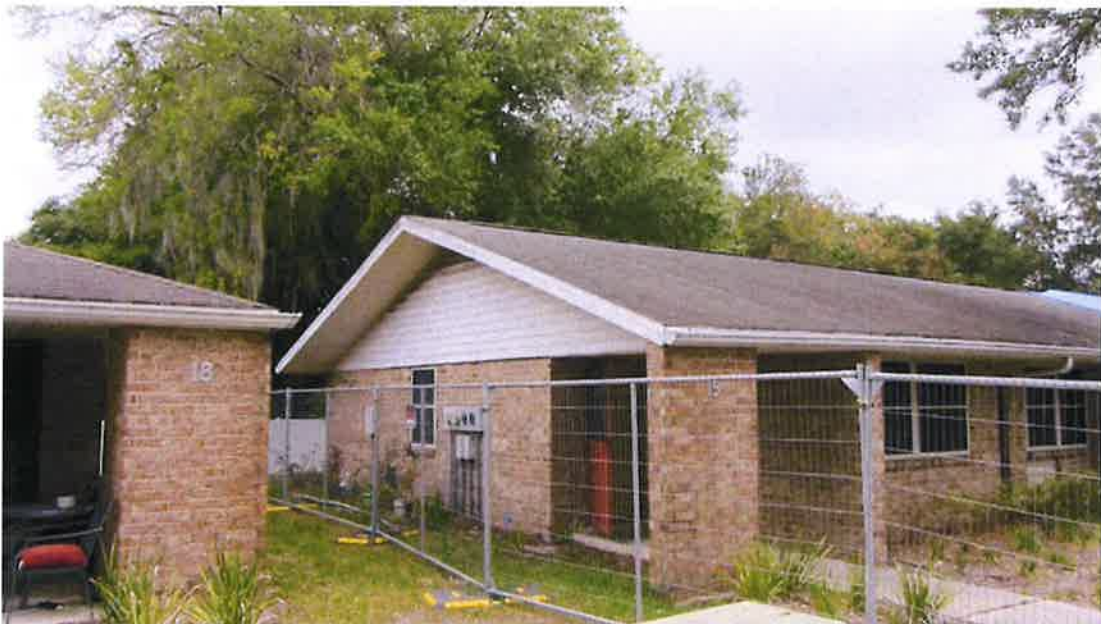
Photograph 2) – Left (south) elevation at Unit #19.

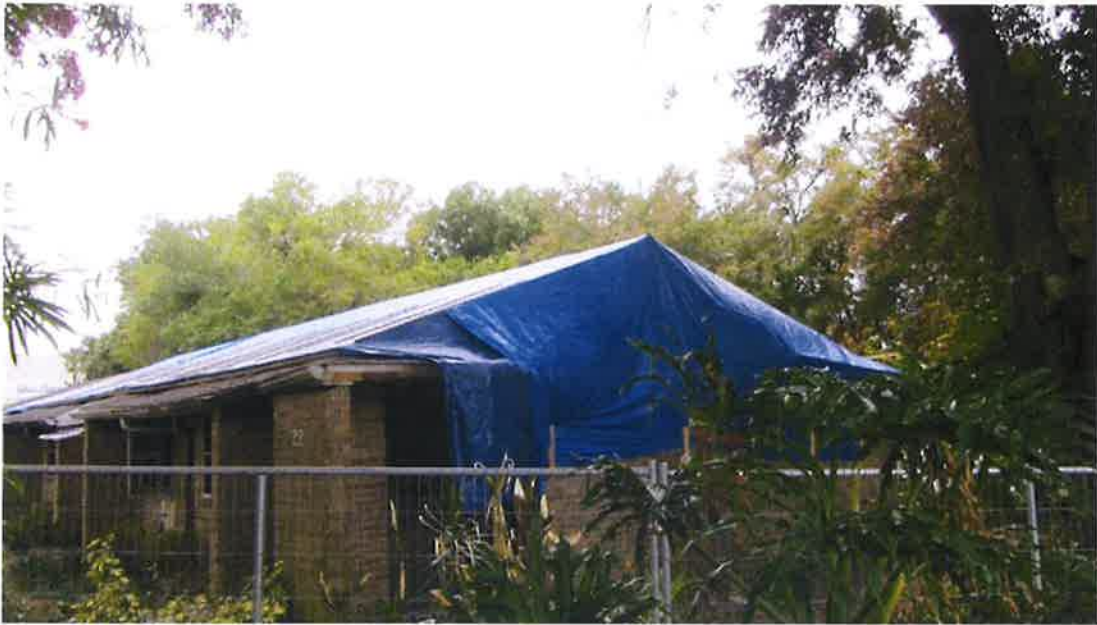
Photograph 3) – Right (north) elevation at Unit #22.

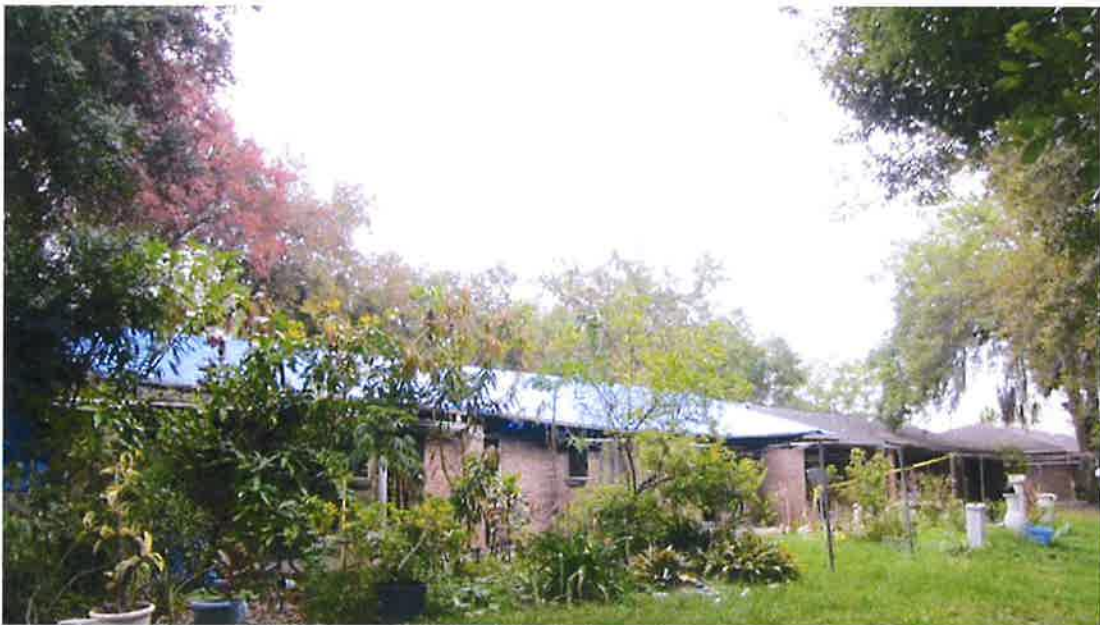
Photograph 4) – Rear (west) elevation.

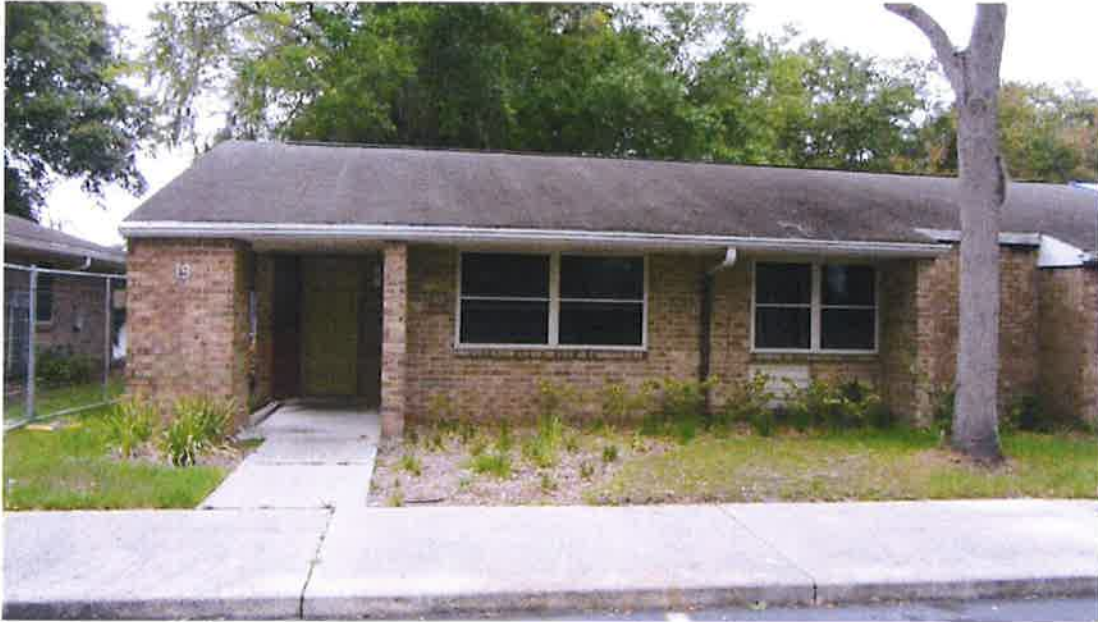
Photograph 5) – Exterior view of Unit #19.

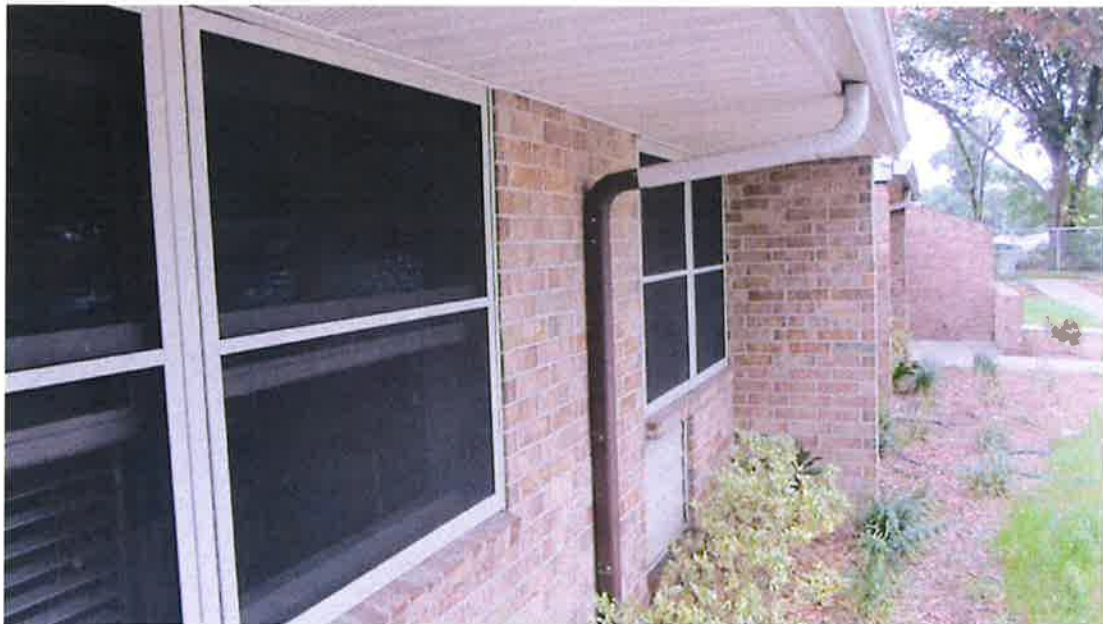
Photograph 6) – View looking north along the front elevation of Unit #19.

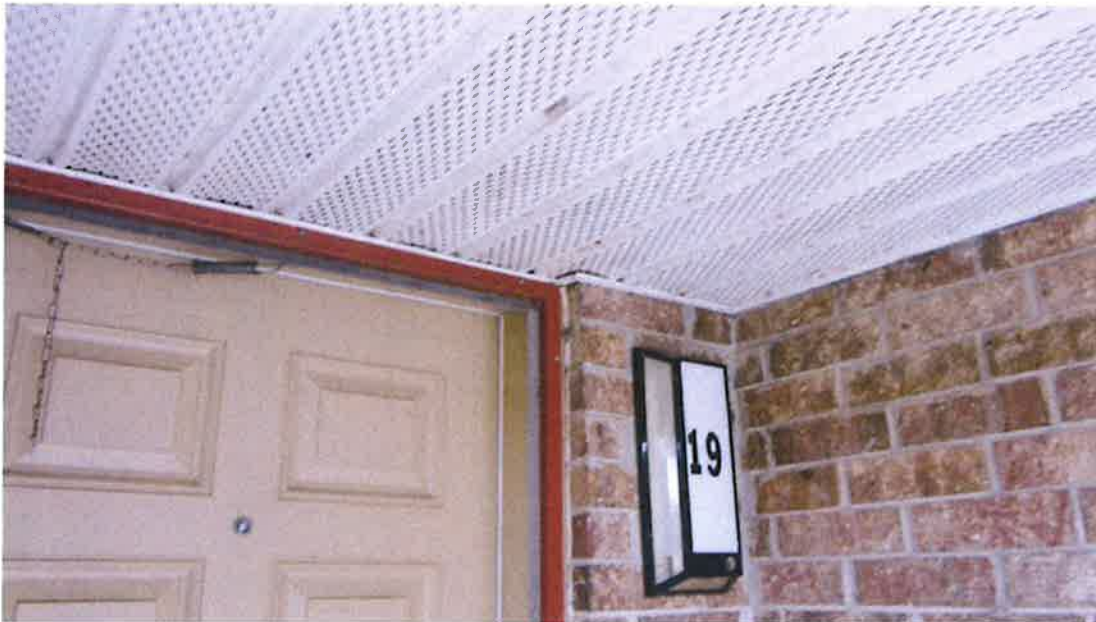
Photograph 7) – Close-up view of the exterior of Unit #19 at the front entry foyer.

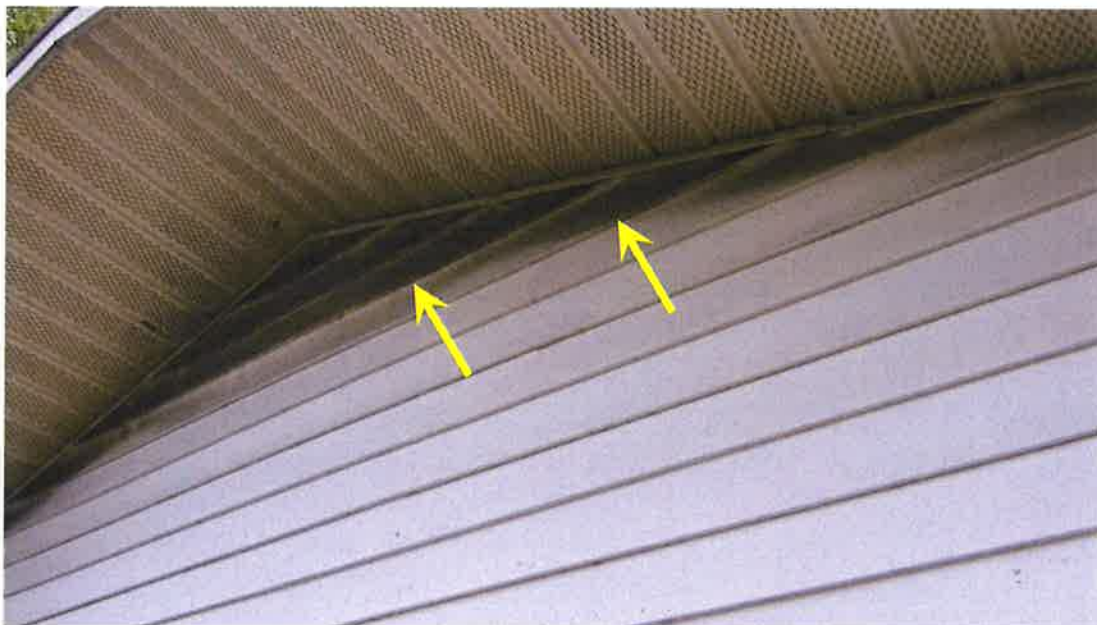
Photograph 8) – Close-up view of the soffit overhang and gable end siding at the south end of Unit #19. Arrows indicate fire-related effects from smoke.

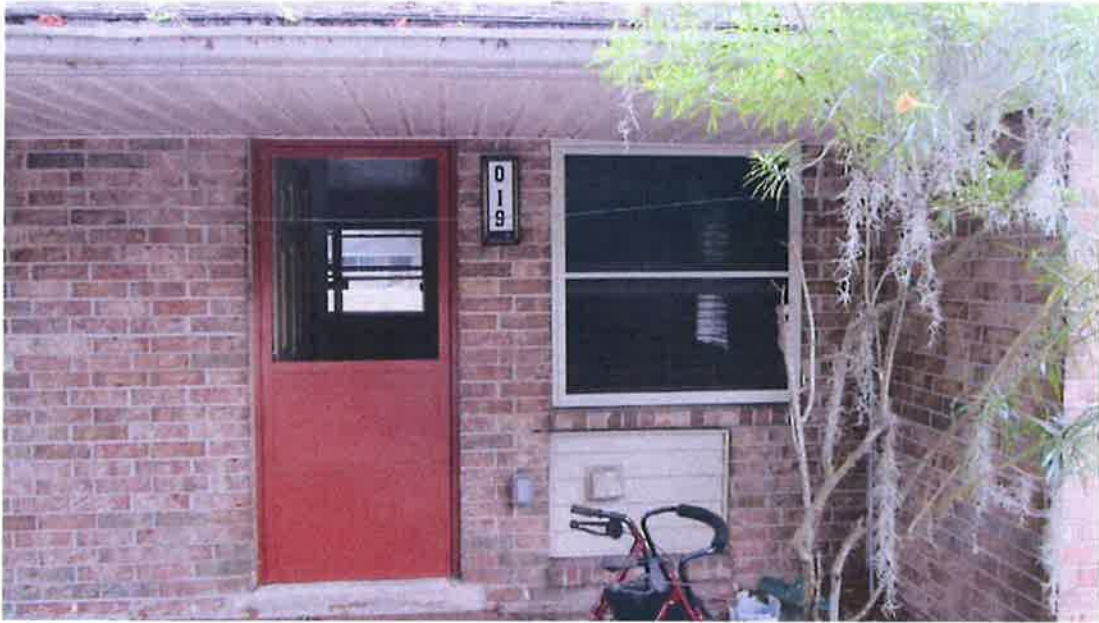
Photograph 9) – View looking east at the rear covered patio of Unit #19.

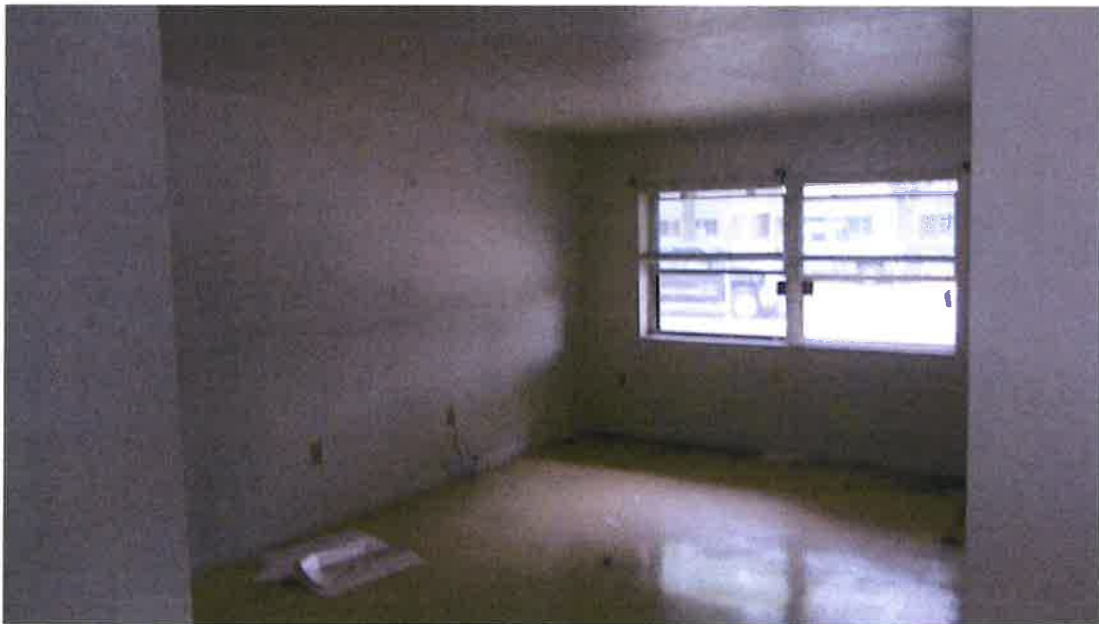
Photograph 10) – View looking northeast into the living room at the front of Unit #19.

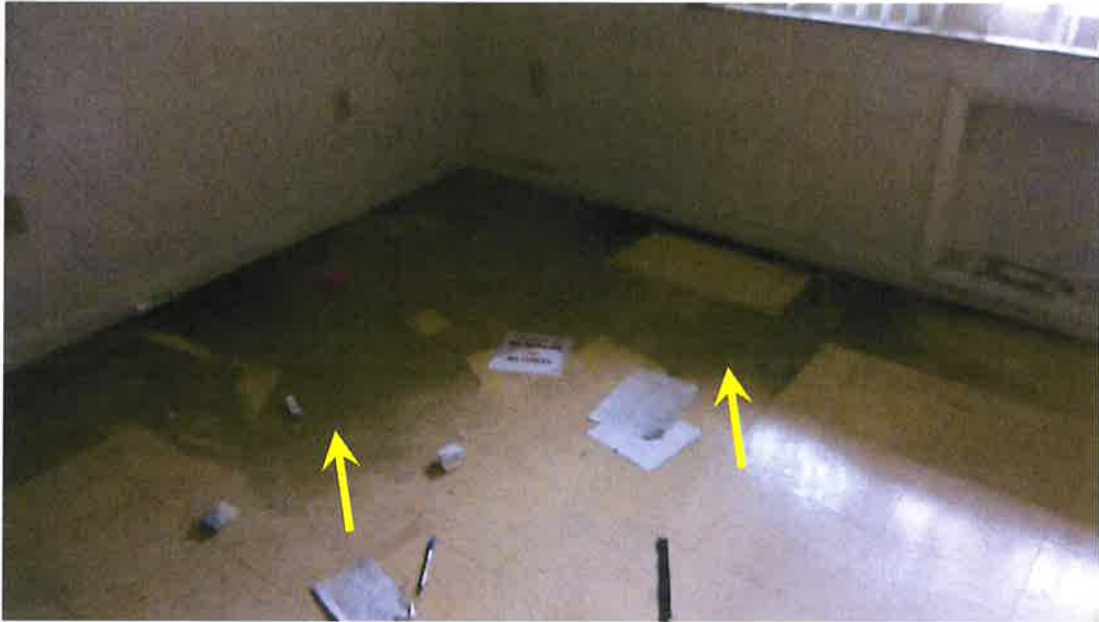
Photograph 11) – View looking northeast into the bedroom at the front of Unit #19. Arrows indicate fire-related effects from smoke.

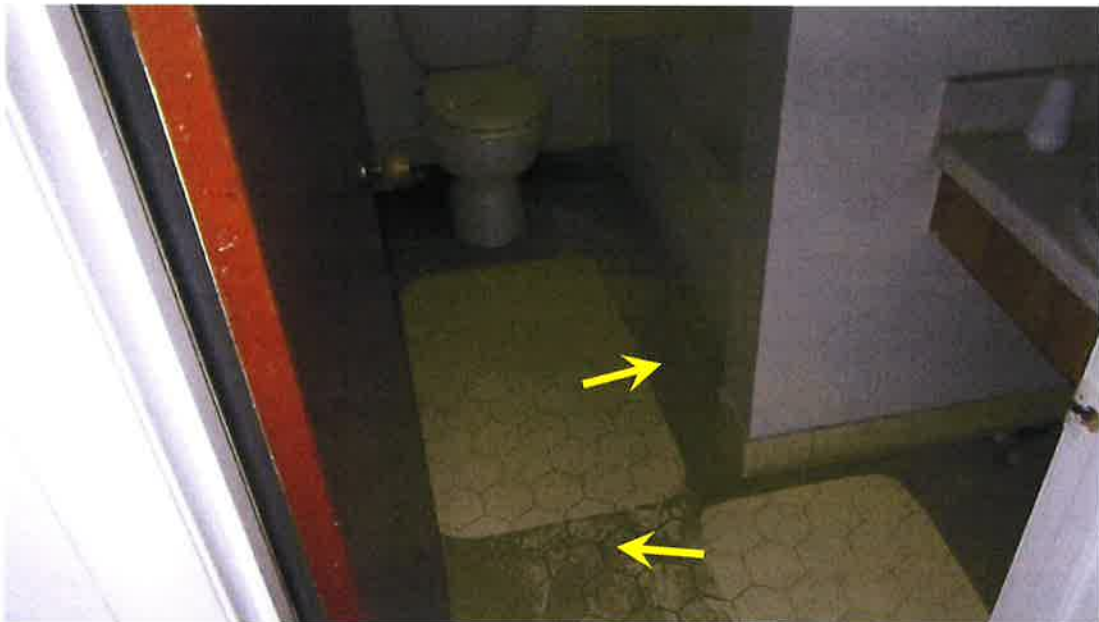
Photograph 12) – View looking west into the bathroom of Unit #19. Arrows indicate fire-related effects from smoke.

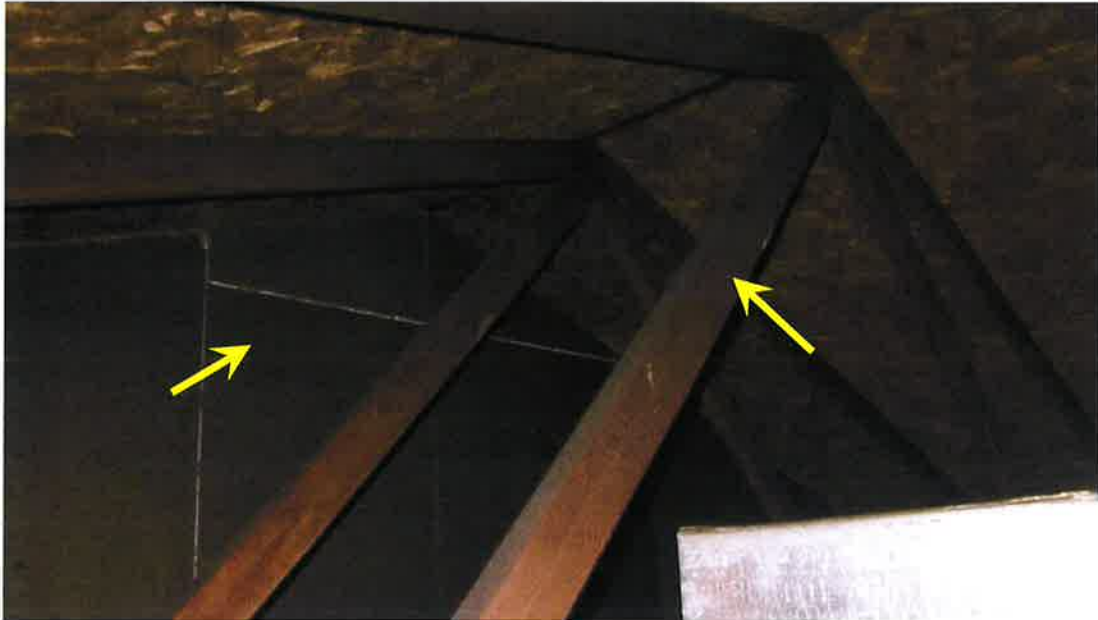
Photograph 13) – View looking north at the wood roof framing above Unit #19. Left arrow indicates the separation wall between Unit #20. Right arrow indicates pre-engineered wood roof truss. Fire-related effects from smoke visible.

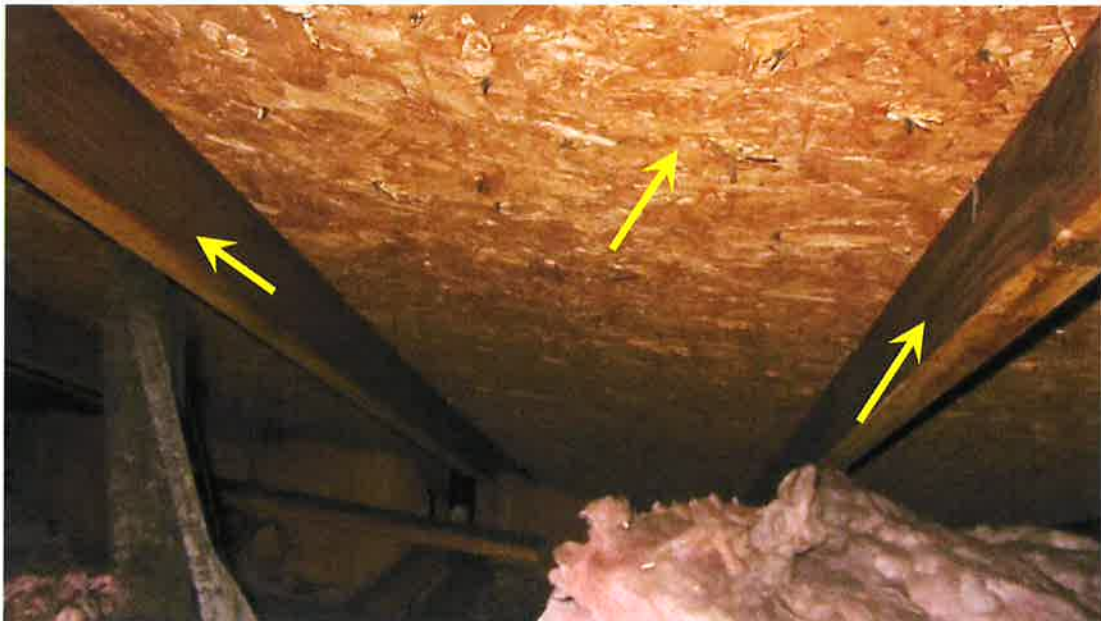
Photograph 14) – Close-up view of the wood roof framing above Unit #19. Middle arrow indicates the OSB sheathing. Left and right arrows indicate pre-engineered wood roof truss. Fire-related effects from smoke visible on roof trusses.

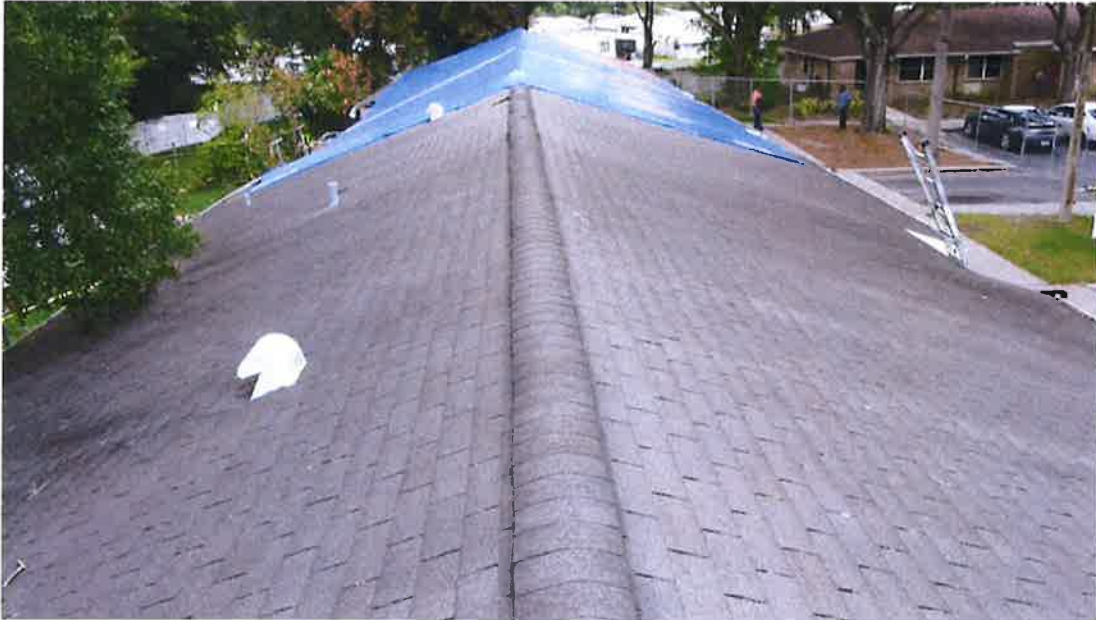
Overviews of the roof above Unit #19 and the southern portion of Unit #20 covered with three-tab, asphalt shingles shown in **Photographs 15 through 22**. **Photograph 23** is a close-up view of the three-tab, asphalt shingles above Unit #20 with an exposure of 5 inches tall by 36 inches wide. The shingles were observed to be brittle, to have good adhesion to the shingle layer below, and to have moderate granule loss. The roof slope of the main gable roof section was approximately 4 inches vertical to 12 inches horizontal (4:12). No evidence of fire-related defects to the three-tab, asphalt shingles that remained was found. The asphalt shingles that remained on the structure were covering Units #19 and the southern portion of Unit #20 and showed evidence of normal age and deterioration. However, the shingles have multiple years of useful service life remaining and do not require repair or replacement from the effects of the fire.

Photograph 15) – Roof overview looking north along the ridge of the roof above Unit #19 and #20.

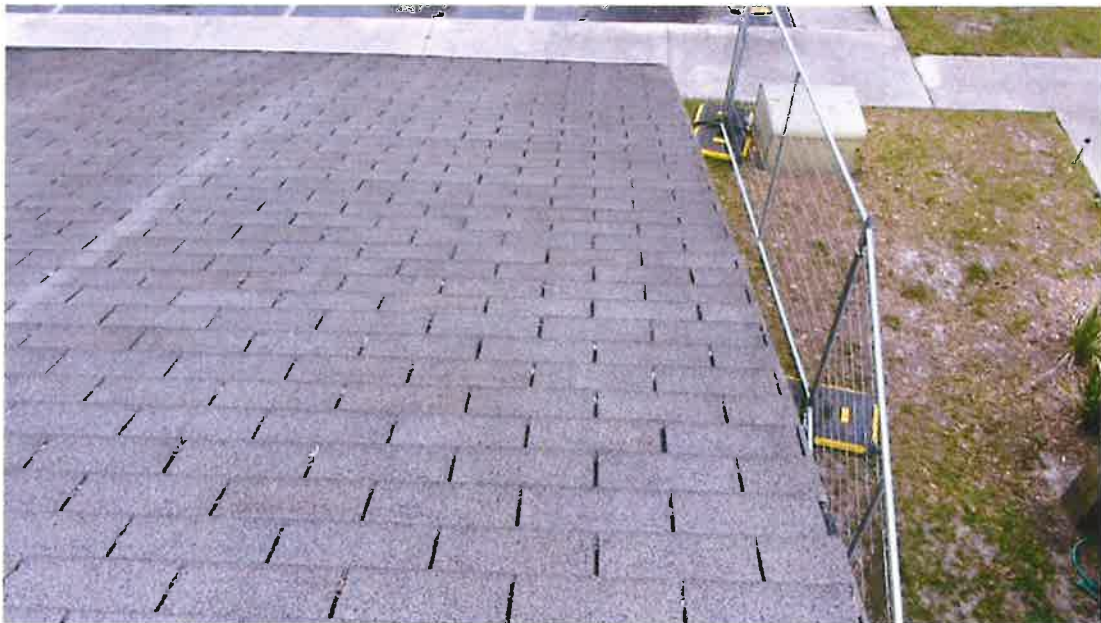
Photograph 16) – Roof overview looking east along the rake at the south gable end above Unit #19.

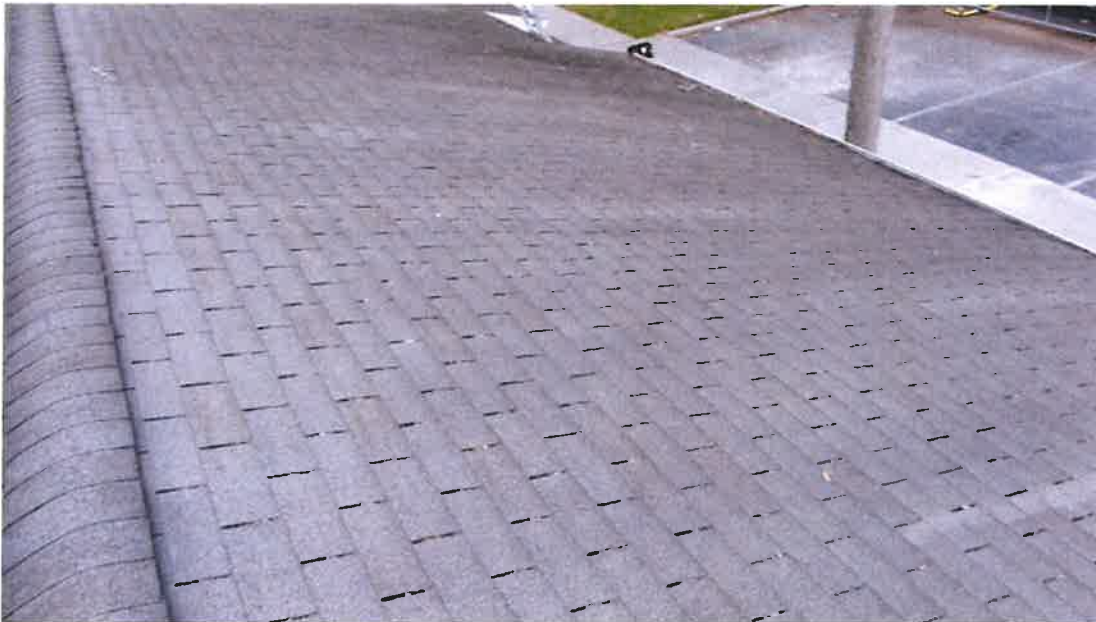
Photograph 17) – Roof overview looking northeast at the field zone of the east slope of the roof above Unit #19.

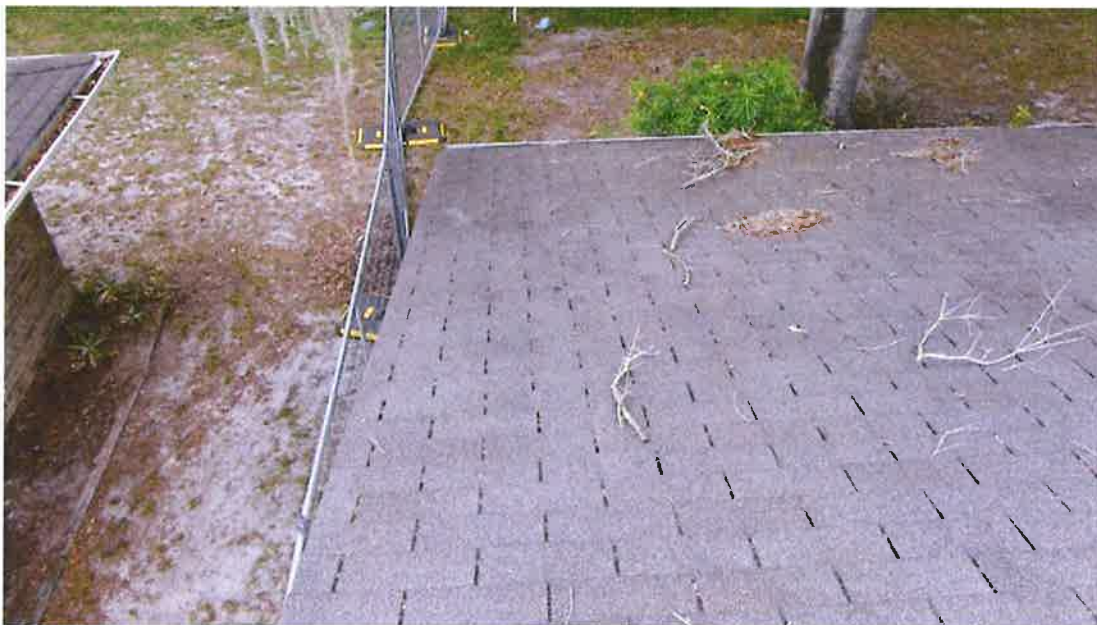
Photograph 18) – Roof overview looking west along the rake at the south gable end above Unit #19.

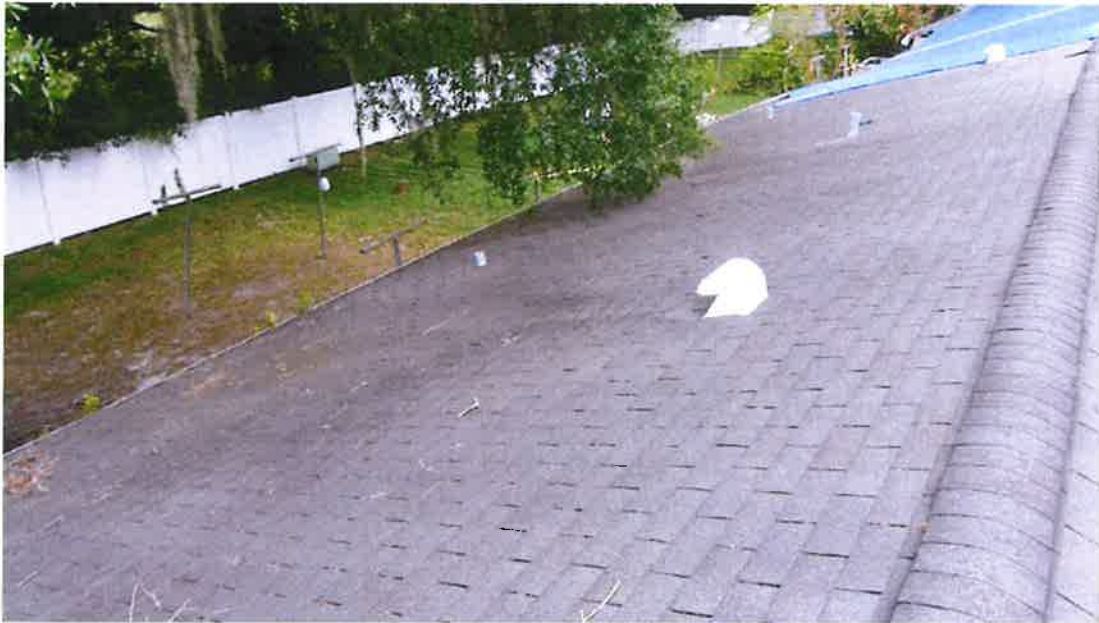
Photograph 19) – Roof overview looking northeast at the field zone of the west slope of the roof above Unit #19.

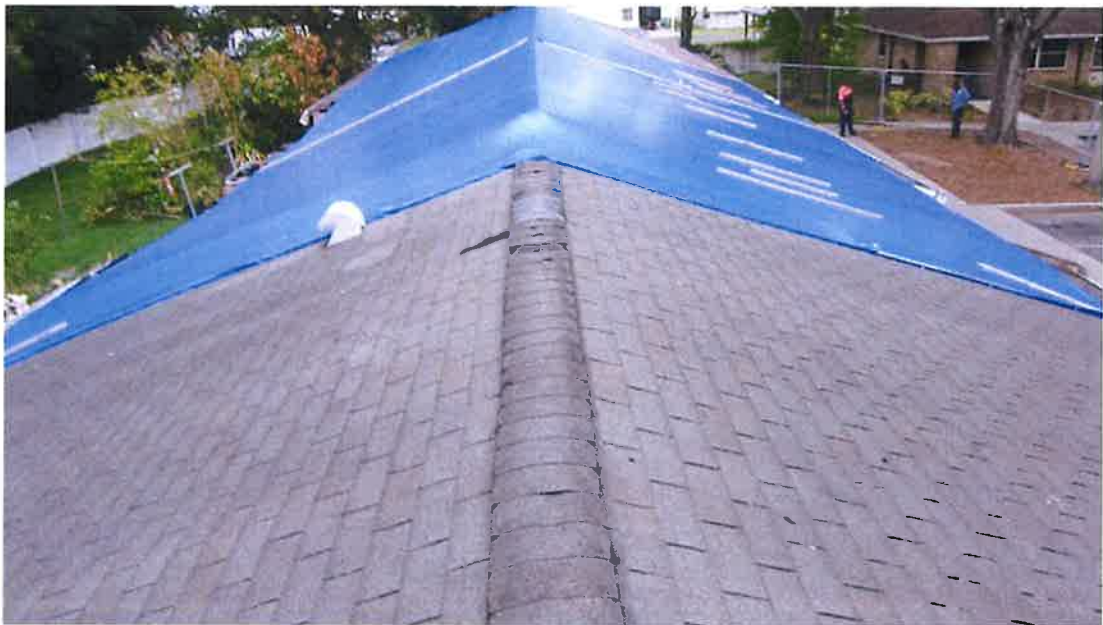
Photograph 20) – Roof overview looking north along the ridge of the remaining roof above the southern portion of Unit #20.

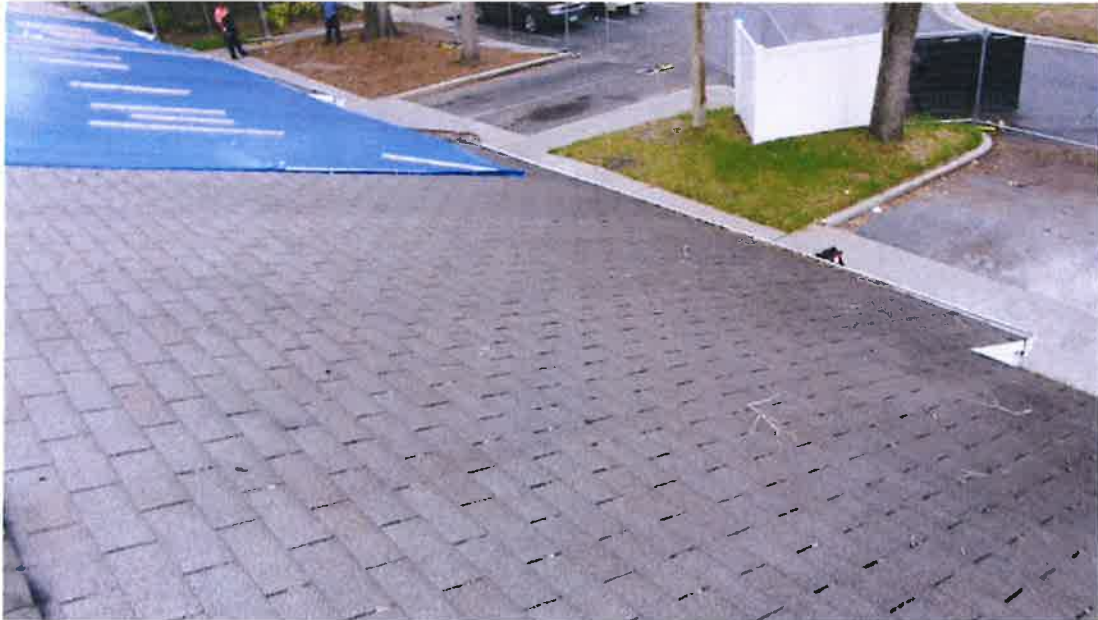
Photograph 21) – Roof overview looking northeast at the field zone of the east slope of the roof above the southern portion of Unit #20.

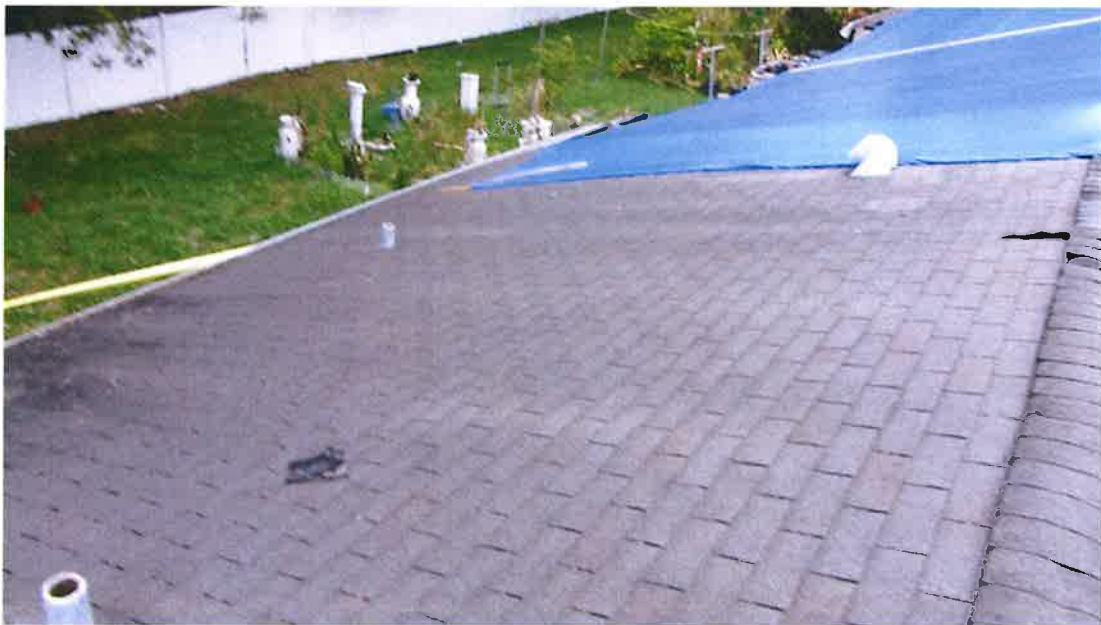
Photograph 22) – Roof overview looking northeast at the field zone of the west slope of the roof above the southern portion of Unit #20.

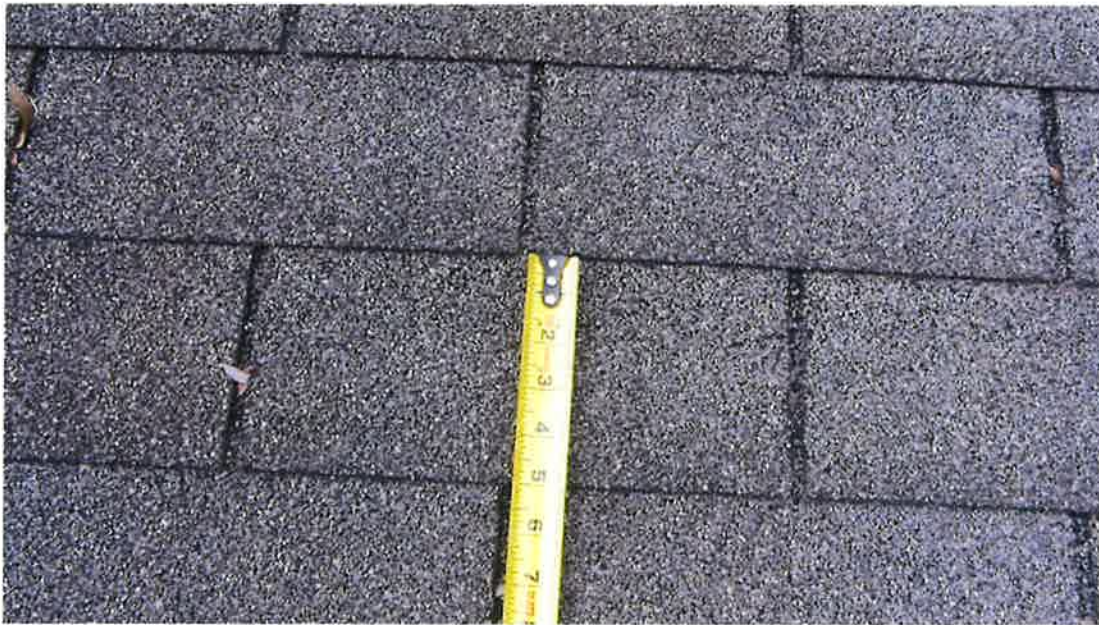
Photograph 23) – Close-up view of the three-tab, asphalt shingles above Unit #20 with an approximate exposure of 5 inches tall by 36 inches wide.

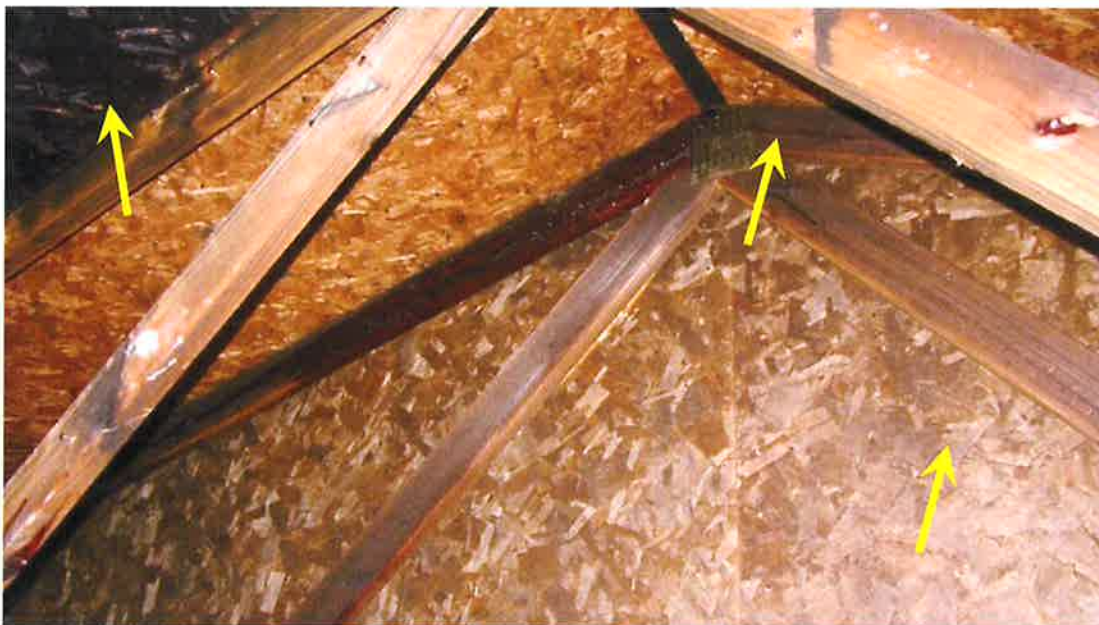
Photographs 24 through 31 show interior views of the approximately 16 pre-engineered wood roof trusses that were remaining and in place above Unit #20 with the southern portion of the 16 wood trusses still covered with oriented strand board (OSB) wood sheathing and asphalt shingles. The northern portion of the 16 wood trusses were covered with the temporary blue tarpaulin covering. Trusses 1 through 7, beginning at the southern end of Unit #20 at the separation wall of Unit #19 and extending to the north for approximately 14 feet, were observed to have minor fire-related effects in the form of smoke stains, but no fire-related damage was observed to the wood trusses or to the OSB wood sheathing. An awl was used to determine the depth of charring and if the wood sustained fire-related damage or only fire-related effects from smoke. These 7 trusses do not require repair or replacement. In addition, no fire-related damage was observed to the metal tie-down fasteners attaching the bottom chord of the wood trusses to the top plates of the interior and exterior load-bearing walls (Photographs 30 through 32). All the roof framing members and the roof covering system located to the north of the 7th wood truss located approximately 14 feet from the southern end of Unit #20, sustained severe fire-related damage and require complete replacement.

Photograph 24) – View looking south in the attic space above the southern portion of Unit #20. Right arrow indicates the separation wall between Unit #19. Middle and left arrows indicate fire-related effects from smoke.

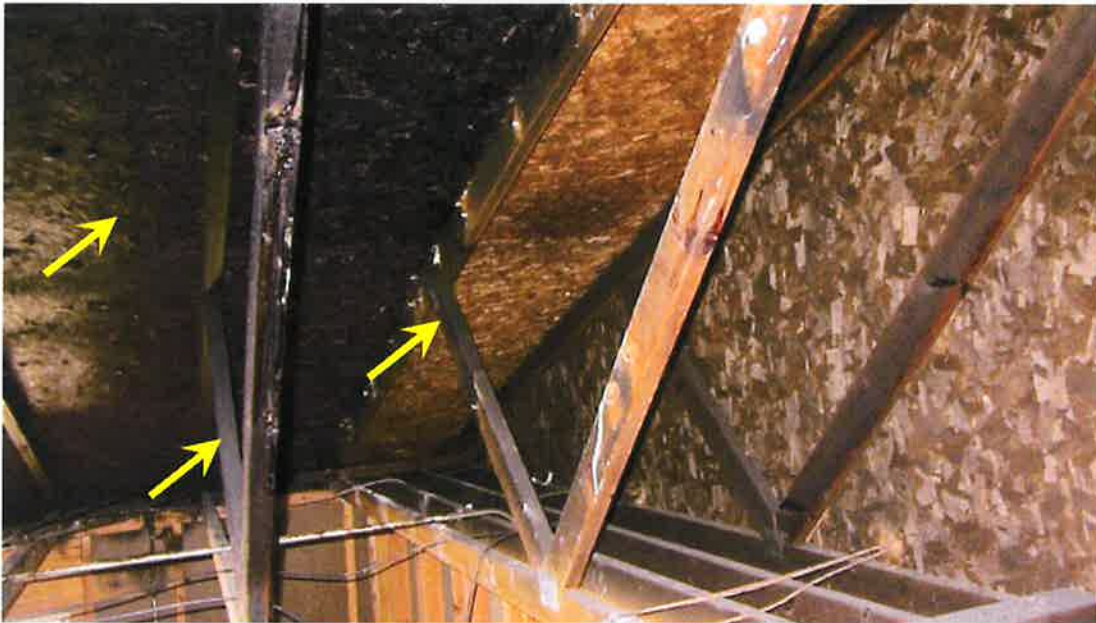
Photograph 25) – View looking east at the wood roof framing system above the southern portion of Unit #20. Arrows indicate fire-related effects from smoke.

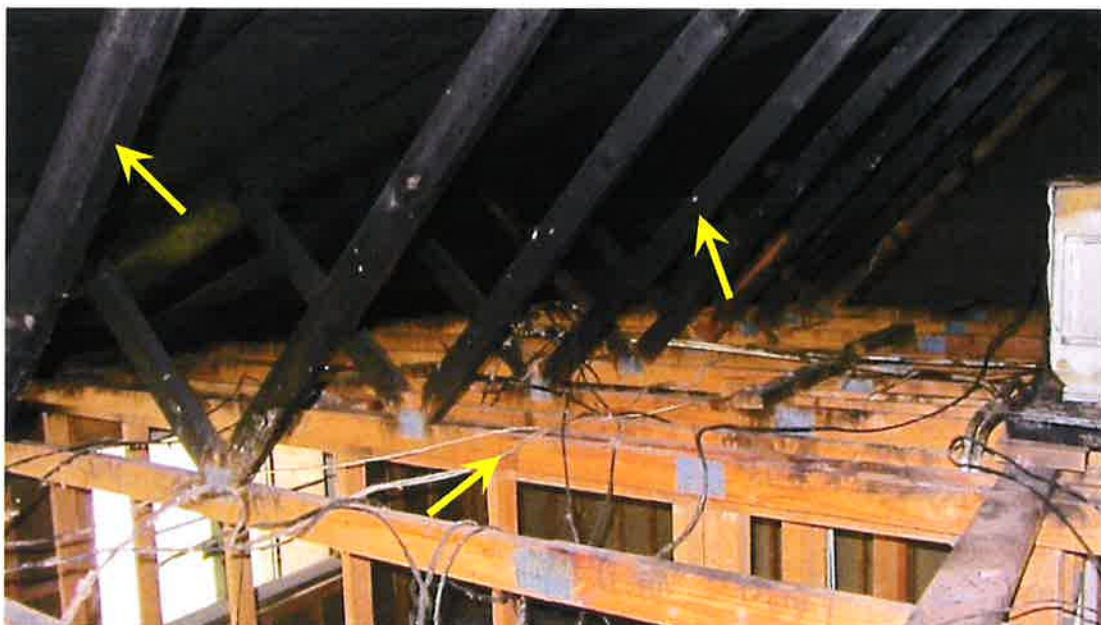
Photograph 26) – View looking southeast at pre-engineered Trusses 1 through 7 above the southern portion of Unit #20. Arrows indicate fire-related effects from smoke.

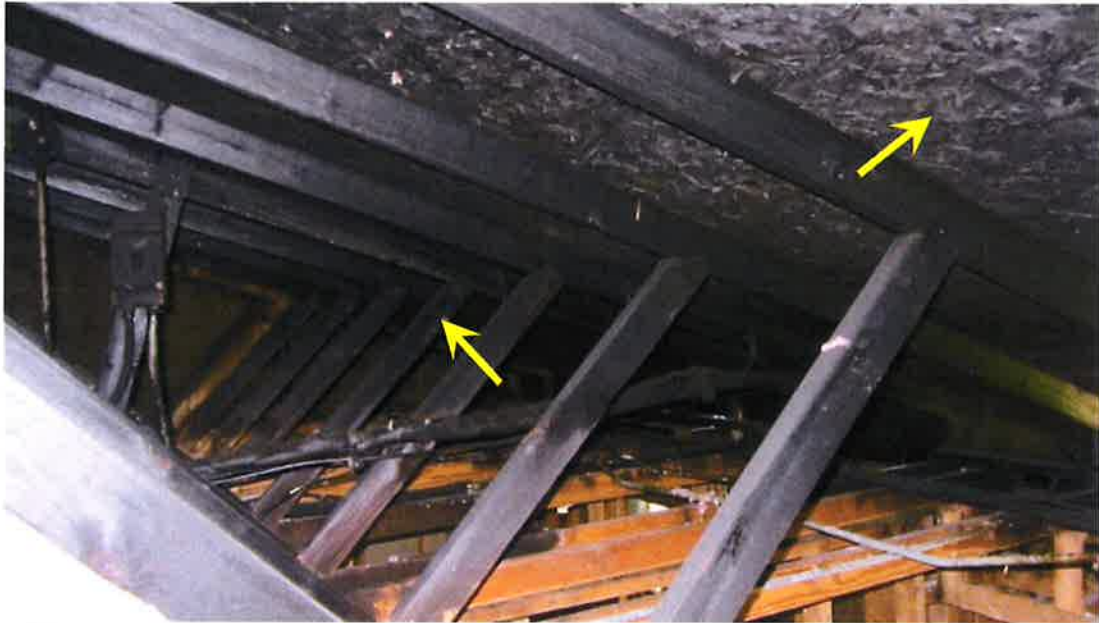
Photograph 27) – View looking southwest at pre-engineered Trusses 1 through 7 above the southern portion of Unit #20. Arrows indicate fire-related effects from smoke.

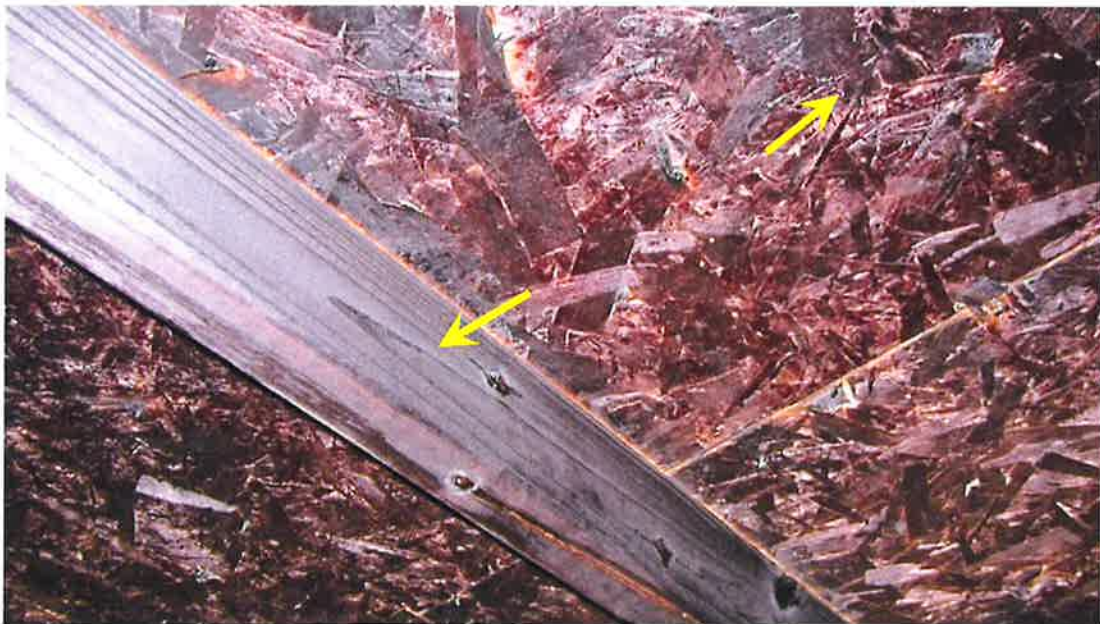
Photograph 28) – Close-up view of the fire-related effects from smoke on the pre-engineered wood truss and OSB sheathing.

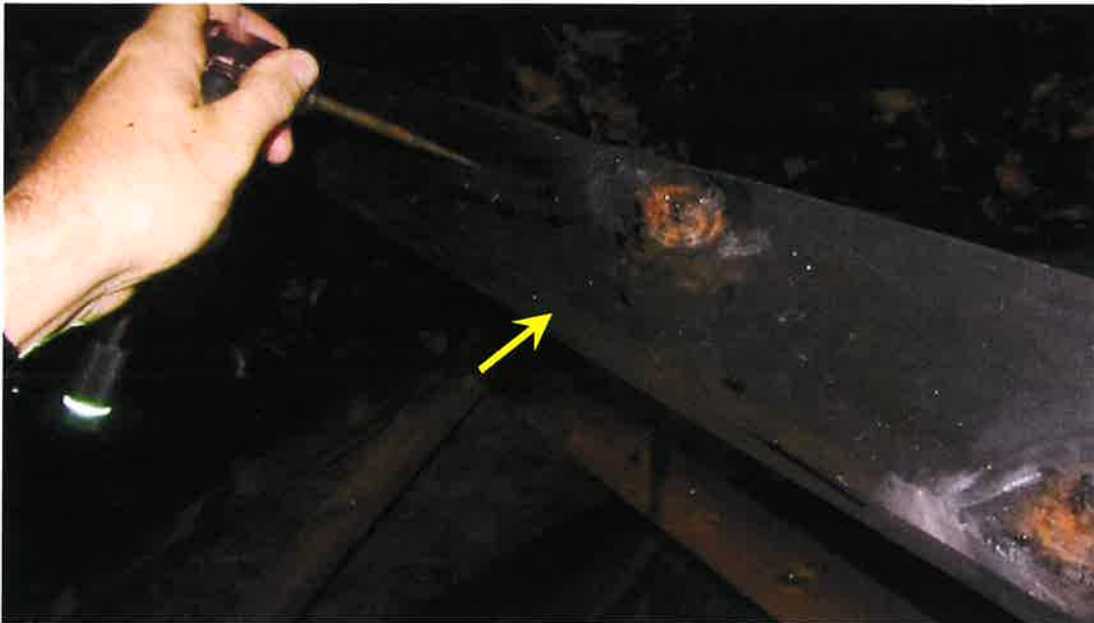
Photograph 29) – Close-up view of a pre-engineered wood truss above Unit #20 with fire-related effects from smoke. No structural damage was found when probed with the awl.

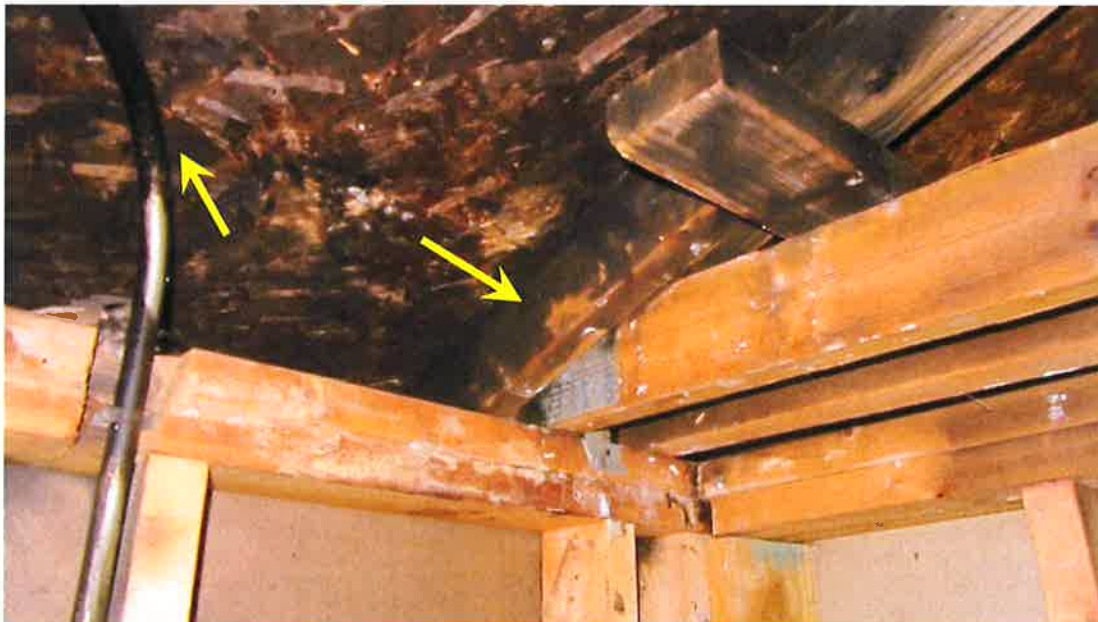
Photograph 30) – View of the east end of Truss 2 at the southern portion of Unit #20 and the connection to the top plate of the exterior wall. Arrows indicate fire-related effects from smoke.
