INVITATION FOR BIDS
Structural Repairs and Replacement Construction at Cecil Gober
Villas Apartments Units #19-20-21-22

The Housing Authority of the City of Lakeland (herein referred to as "*LHA*") hereby requests bids from licensed and qualified contractors for the repair of fire damage to Units 19, 20, 21, 22 of Cecil Gober Villas Apartments. The repairs must result in the unit being in an *equal to* or *better than* condition than existed prior to the damage. The Scope of Work generated by the insurance adjuster is attached herein as *Exhibit "A"*.

As requested, Jesse W. Curtis, P.E., a FORCON International Corporation (FORCON) Consultant and Professional Civil/Structural Engineer, performed a site investigation and evaluation of reported fire damage at the subject property. The site investigation was performed on June 21, 2021. Mr. Bert McFarlane, representing the insured, provided access to the exterior, interior, and roof of the subject property. The purpose of the investigation was to evaluate the alleged fire damage in the building containing four dwelling units. **FORCON's scope included a structural evaluation of the interior and exterior building to identify building e

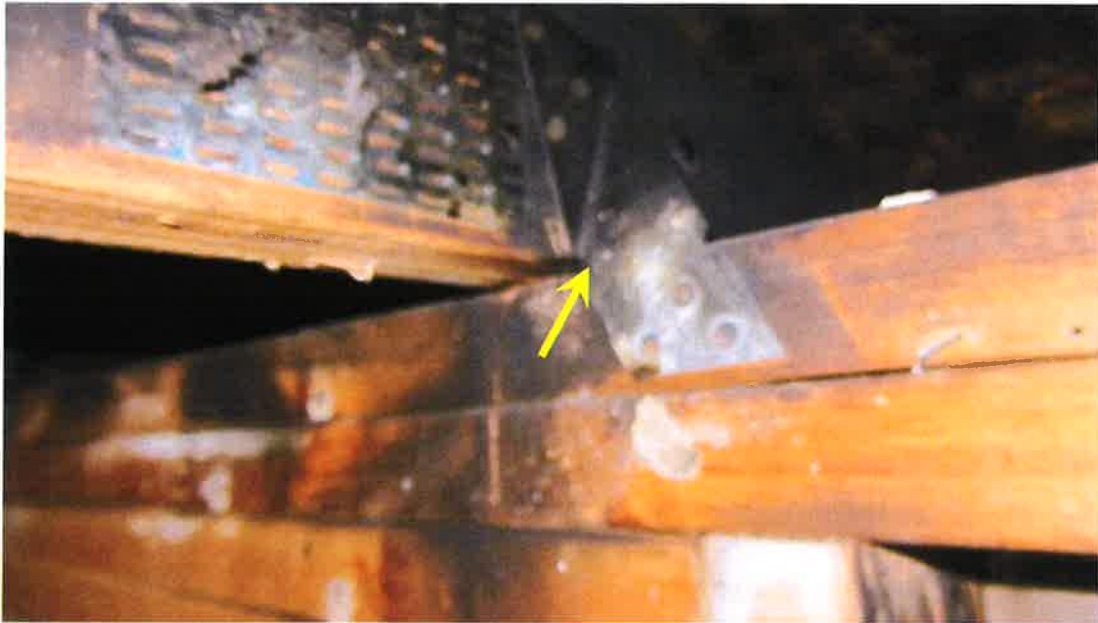
Photographs 24 through 31 show interior views of the approximately 16 pre-engineered wood roof trusses that were remaining and in place above Unit #20 with the southern portion of the 16 wood trusses still covered with oriented strand board (OSB) wood sheathing and asphalt shingles. The northern portion of the 16 wood trusses were covered with the temporary blue tarpaulin covering. Trusses 1 through 7, beginning at the southern end of Unit #20 at the separation wall of Unit #19 and extending to the north for approximately 14 feet, were observed to have minor fire-related effects in the form of smoke stains, but no fire-related damage was observed to the wood trusses or to the OSB wood sheathing. An awl was used to determine the depth of charring and if the wood sustained fire-related damage or only fire-related effects from smoke. These 7 trusses do not require repair or replacement. In addition, no fire-related damage was observed to the metal tie-down fasteners attaching the bottom chord of the wood trusses to the top plates of the interior and exterior load-bearing walls (Photographs 30 through 32). All the roof framing members and the roof covering system located to the north of the 7th wood truss located approximately 14 feet from the southern end of Unit #20, sustained severe fire-related damage and require complete replacement.

Photograph 31) – Close-up view of a metal tie-down fastener connection of the wood truss and the top plate of the exterior wall. No fire-related damage was observed.

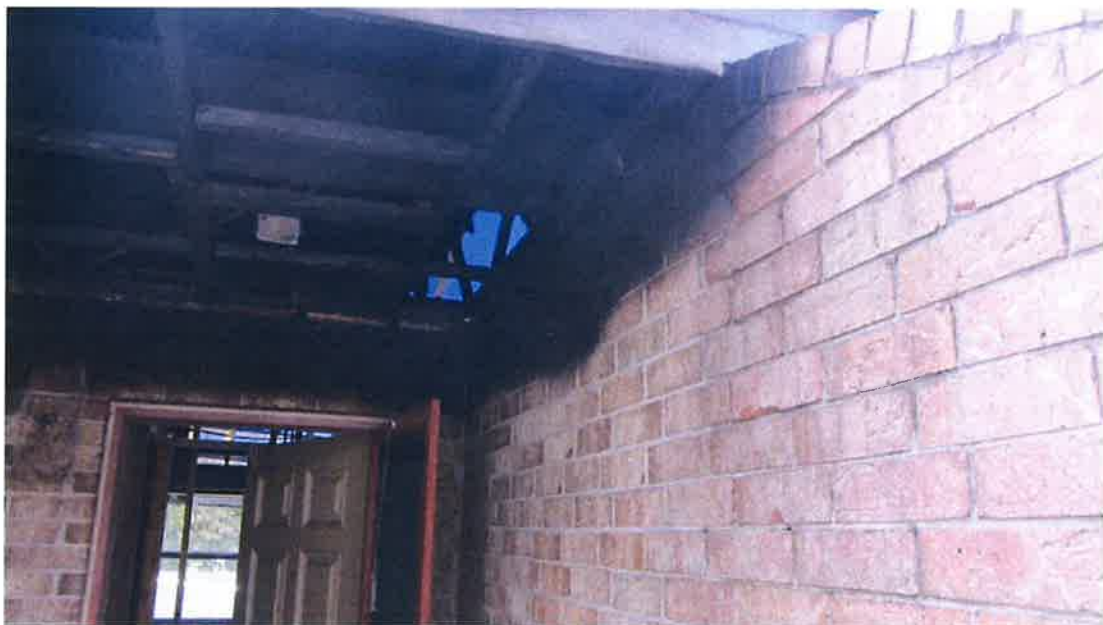
The roof and ceiling framing systems located at the front entry foyers of Units #20 and #21 also sustained fire-related damage. **Photographs 32 through 37** show views of the roof and ceiling framing system at Unit #20. All wood framing members as well as the OSB wood sheathing require replacement except for the double 2x12 wood header beam. Photographs 36 and 37 show close-up views of both sides of the wood header. The east face of the header sustained minor fire-related damage in the form of light to moderate charring. The layer of wood that experienced charring can be considered to have lost all strength in the depth of that layer. However, due to its low thermal conductivity properties, the wood beneath the charred layer can be assumed to have no significant loss of strength. The double 2x12 wood header beam can be repaired by sistering a new 2x12 wood framing member with the existing double 2x12 header. All the roof and ceiling framing system at the front exterior entry foyer of Unit #21, including the 2x12 wood header beam, sustained fire-related damage requiring complete replacement.

Photograph 32) – View looking west at the front entry foyer of Unit #20.

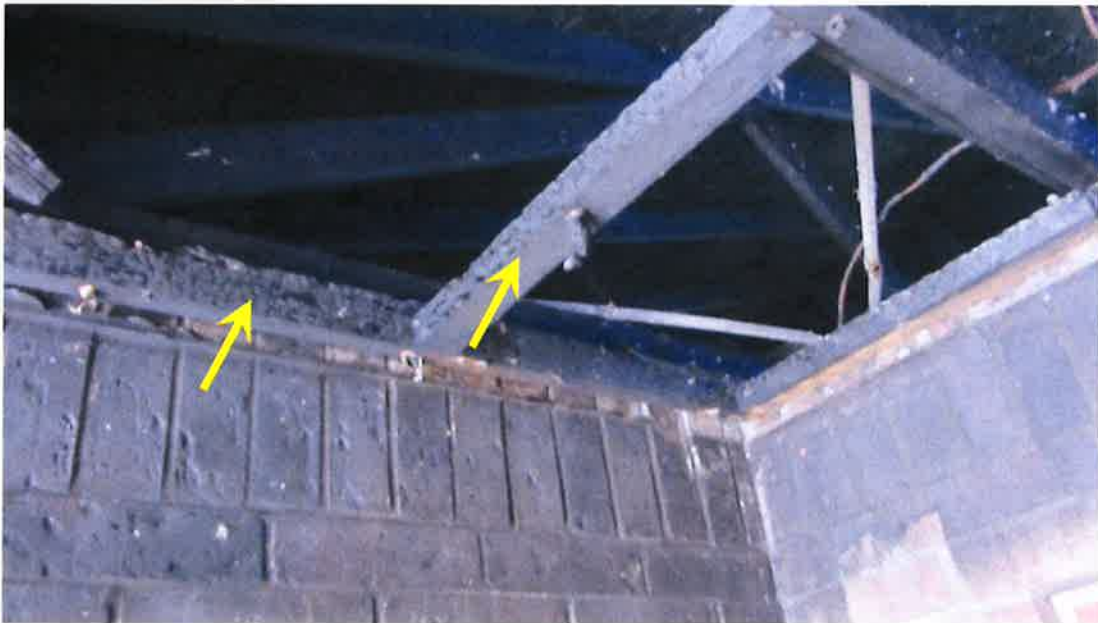
Photograph 33) – Close-up view the upper exterior wall at the front entry foyer of Unit #20. Arrow indicates fire-related damage to the wood ceiling framing.

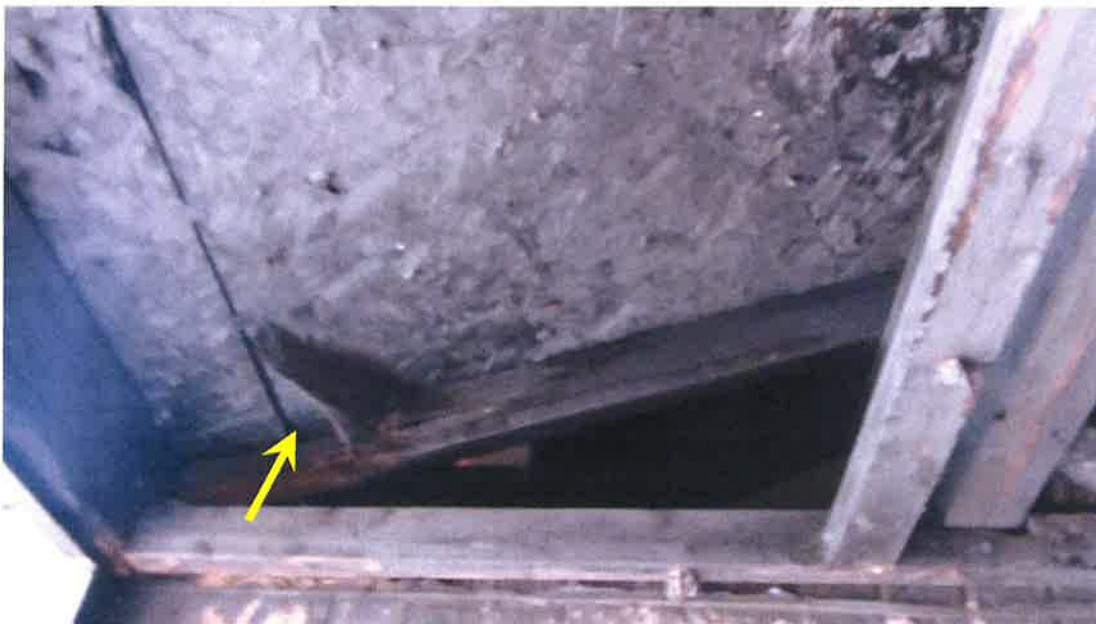
Photograph 34) – Close-up view of OSB sheathing and wood roof and ceiling framing above the front entry foyer of Unit #20 requiring replacement.

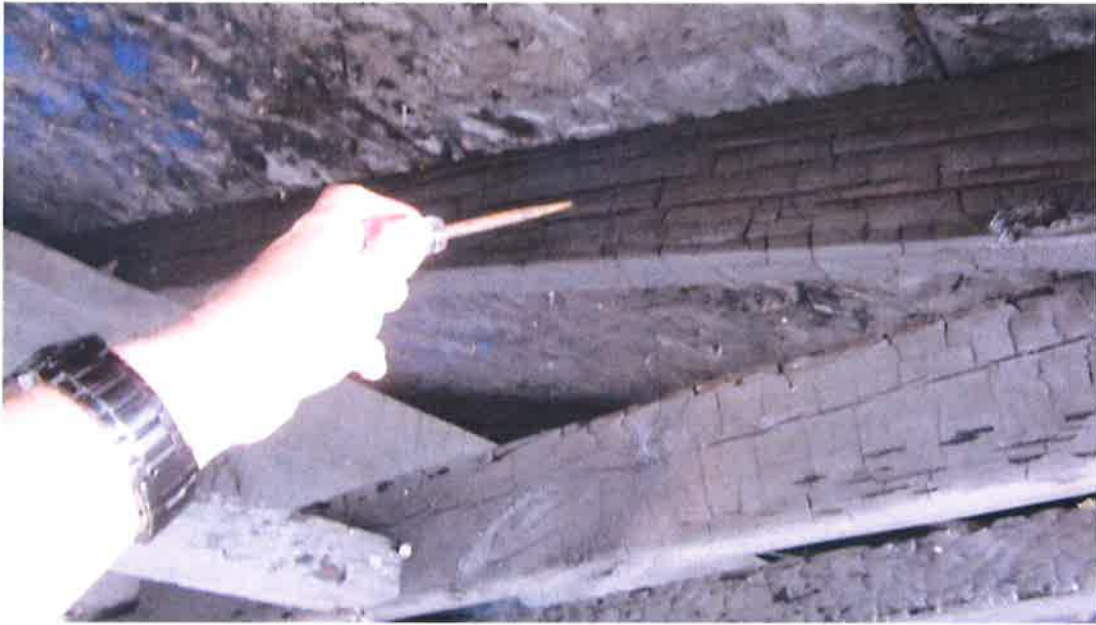
Photograph 35) – Close-up view of OSB sheathing and wood roof and ceiling framing above the front entry foyer of Unit #20 requiring replacement.

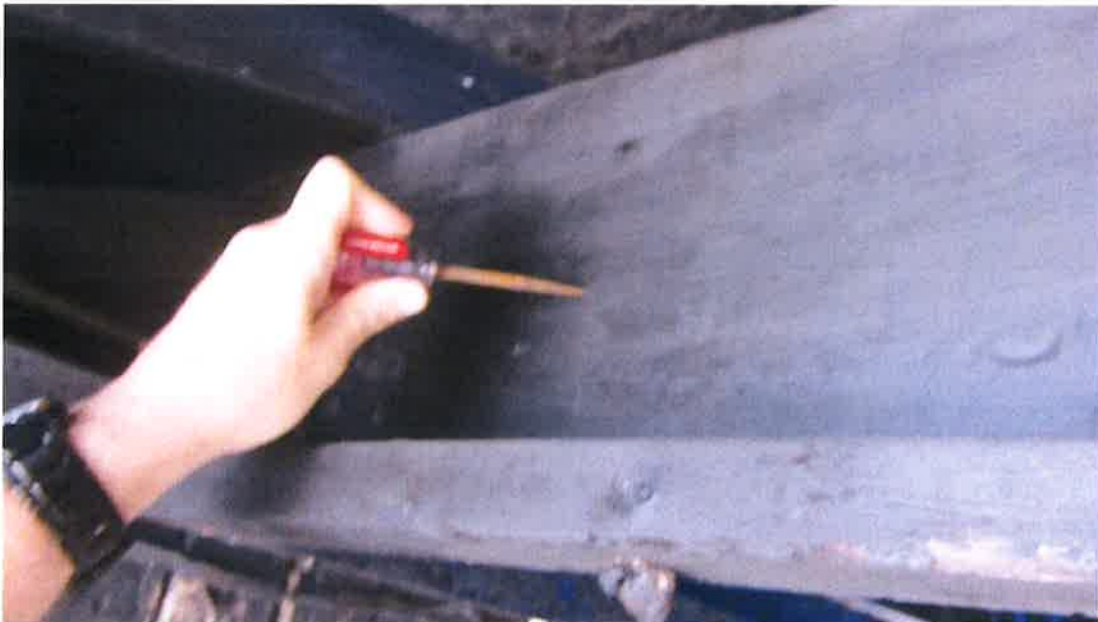
Photograph 36) – Close-up view of the east face of the double 2x12 wood header beam at the front entry foyer of Unit #20 requiring repair.

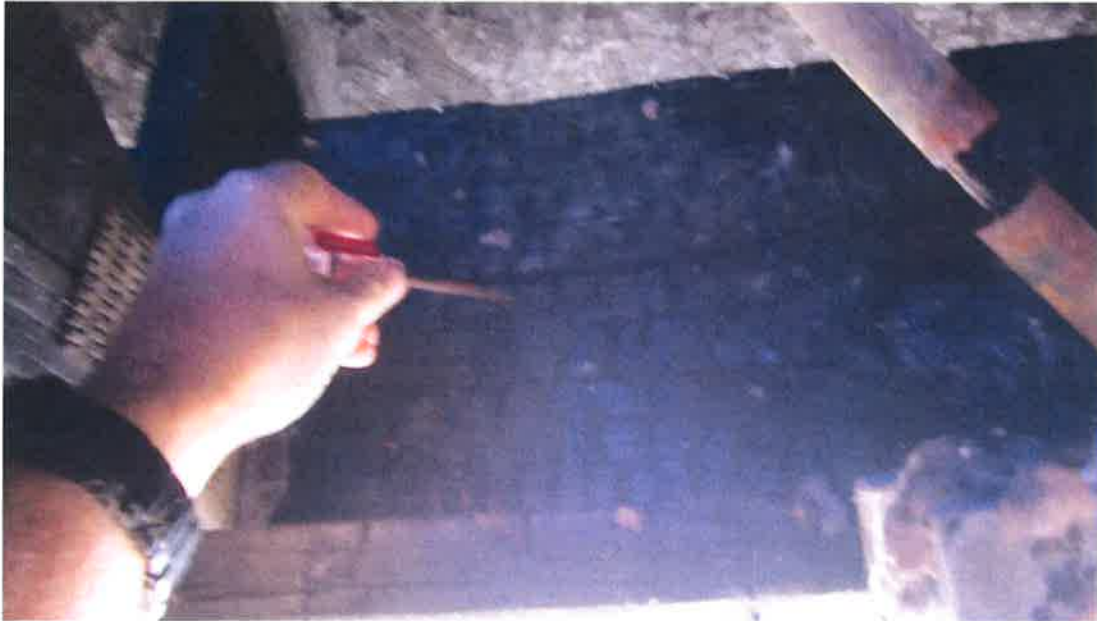
Photograph 37) – Close-up view of the west face of the double 2x12 wood header beam at the front entry foyer of Unit #20 requiring repair.

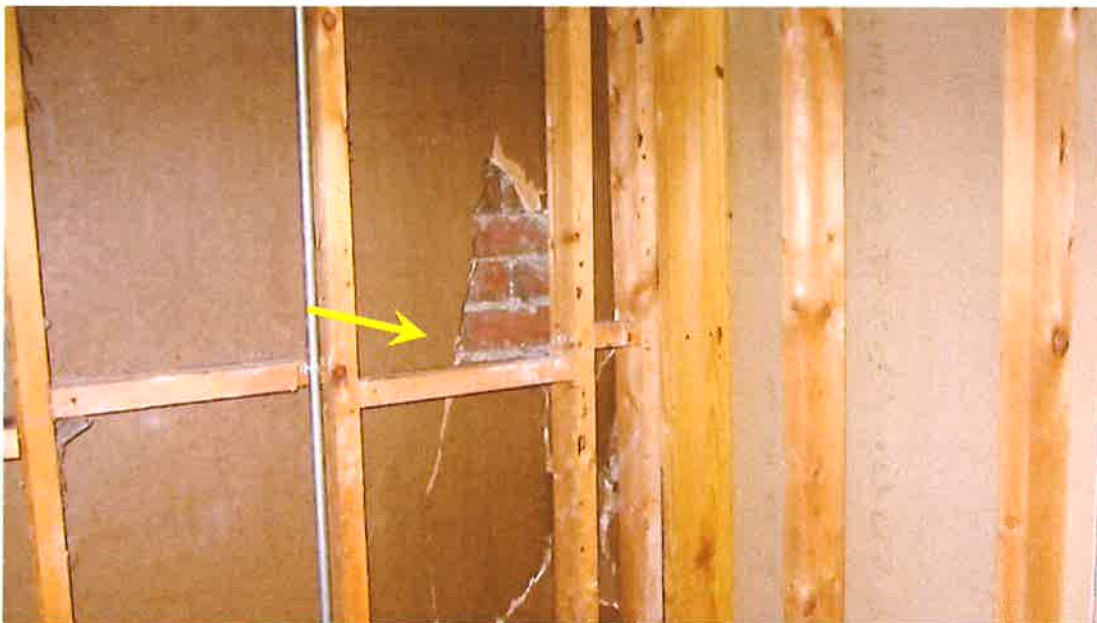
The exterior load-bearing walls consist of 2x4 wood studs and are clad with exterior plywood or drywall sheathing and brick. **Photographs 38 through 48** show views of the exterior load-bearing wall system and the interior 2x4 wood partition walls. Multiple locations throughout Units #20, #21, and #22 sustained fire-related damage to the wall framing in the form of severe charring and require repair or replacement. The portions of the top plate of the 2x4 wood walls should be repaired by removing the severely charred portions and replacing with new 2x4 wood members.

Photograph 38) – Interior view of the exterior load-bearing walls at the southeast corner of Unit #20. A hole in the sheathing requiring repair is visible with the backside of the exterior brick cladding visible.

Multiple locations where the upper portion of the exterior or interior 2x4 wood wall framing system sustained fire-related damage in the form of severe charring requiring repair were observed. These areas of severe damage should be completely replaced with new 2x4 stud framing members and new plywood sheathing. No exterior or interior wood 2x4 walls were observed to have damage to the bottom plate. When a new 2x4 stud framing member is required, the existing bottom plate can remain in place.

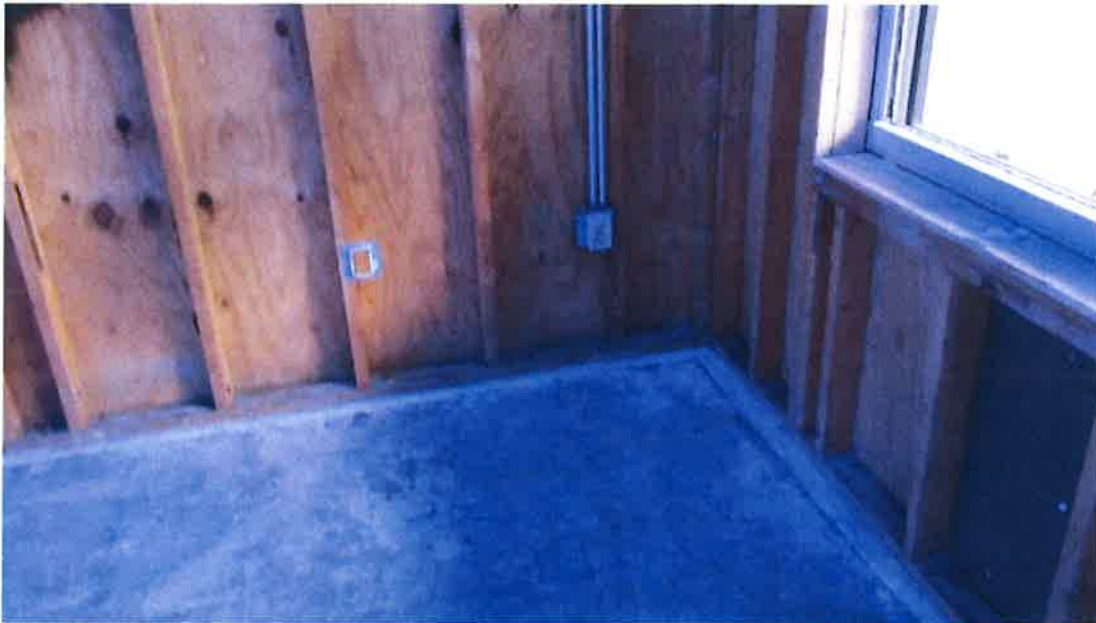
Photograph 39) – Interior view of the exterior load-bearing wall framing.

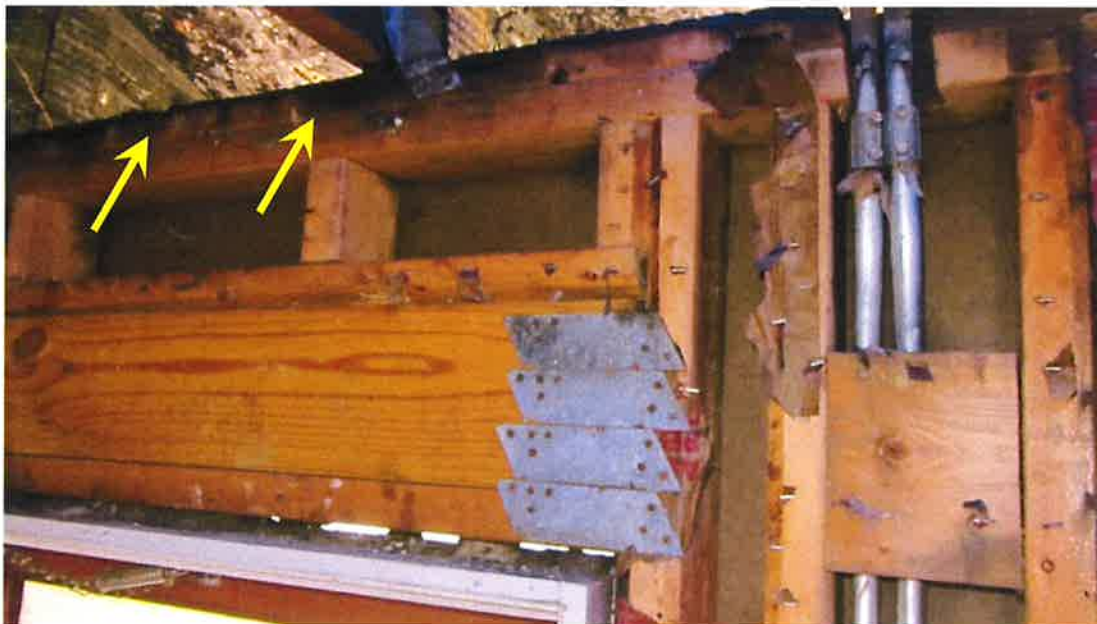
Photograph 40) – Interior view at a header and exterior load-bearing wall framing at the front elevation. Arrows indicate fire-related effects from smoke at the top plate of the wall.

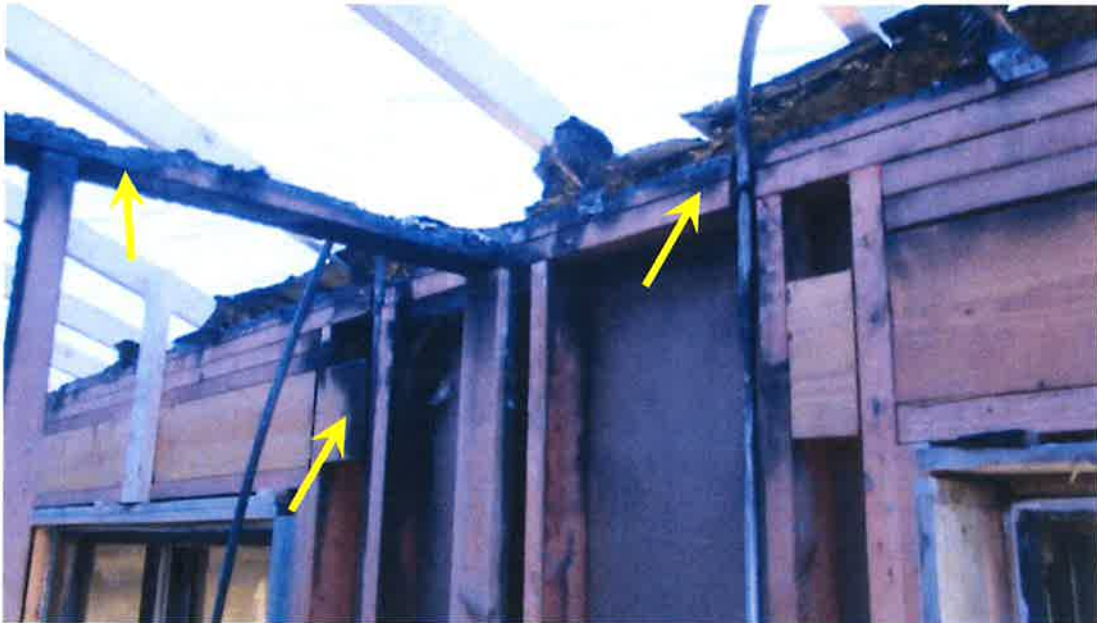
Photograph 41) – Interior view looking southwest at interior partition wall and the rear exterior load-bearing wall at Unit #22. Top left arrow indicates damage to the top plate of the partition wall requiring replacement. Remaining arrows indicate fire-related effects from smoke.

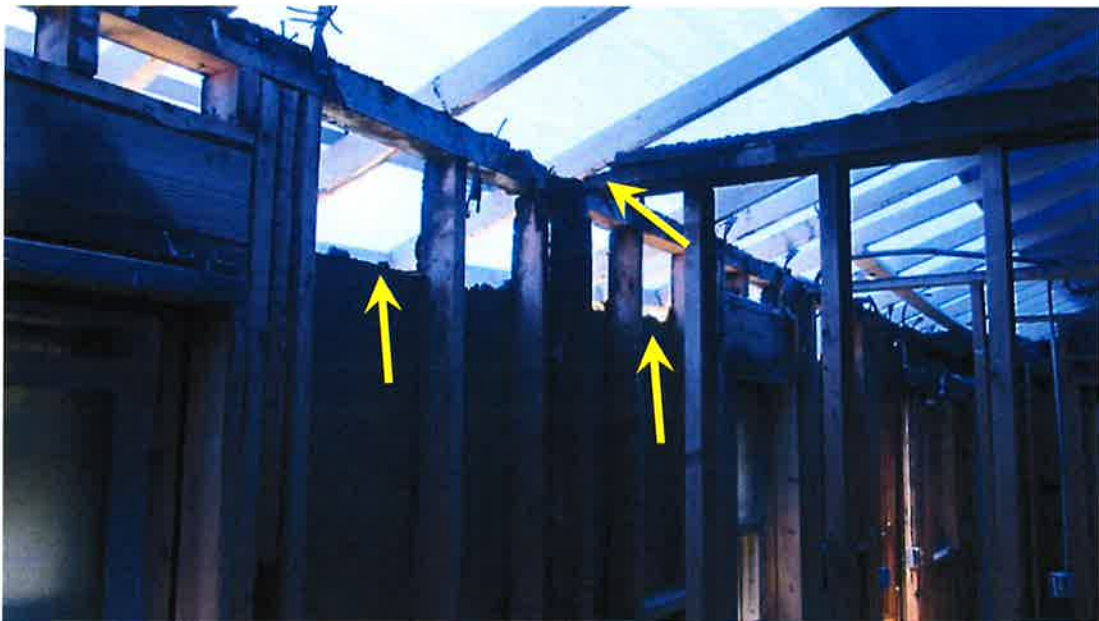
Photograph 42) – Interior view looking northwest at interior partition wall (right) and the rear exterior load-bearing wall of Unit #21. Arrows indicate upper portion of rear load-bearing wall framing system and interior partition requiring replacement.

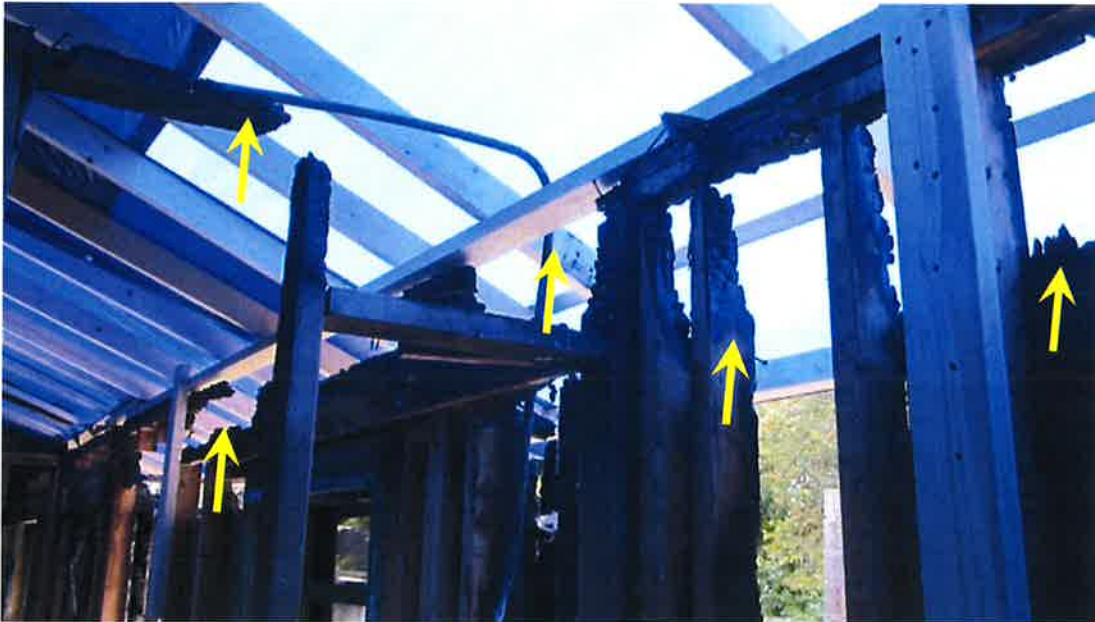
Photograph 43) – Interior view looking southwest at interior partition wall (left) and the rear exterior load-bearing wall of Unit #21. Arrows indicate upper portion of rear load-bearing wall framing system and interior partition requiring replacement.

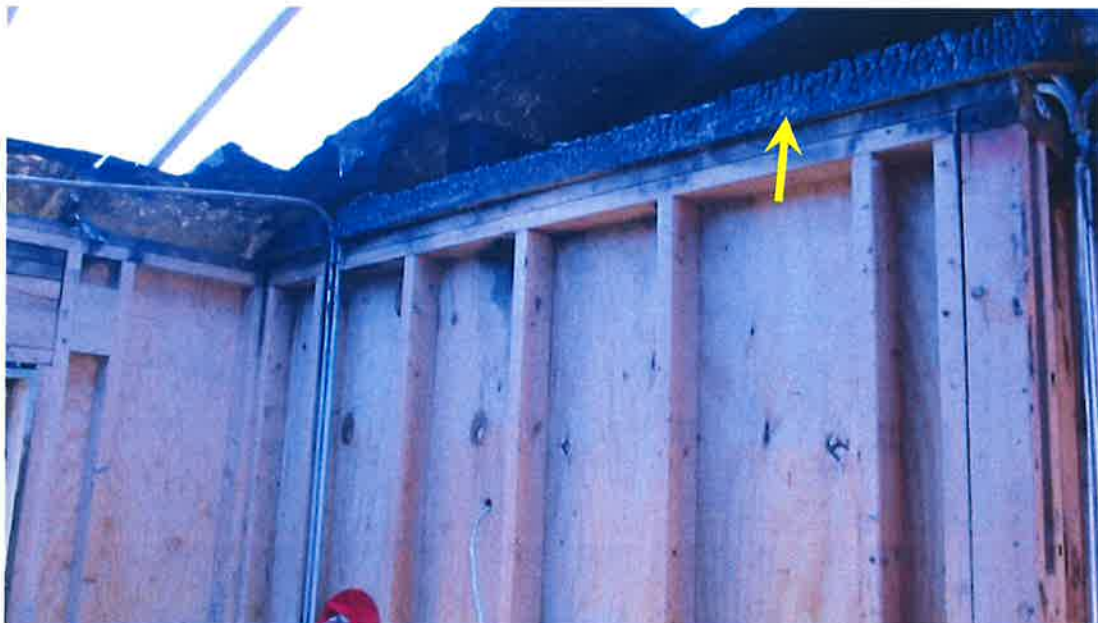
Photograph 44) – Interior view of exterior load-bearing walls at the front of Unit #21. Arrow indicates roof truss requiring replacement.

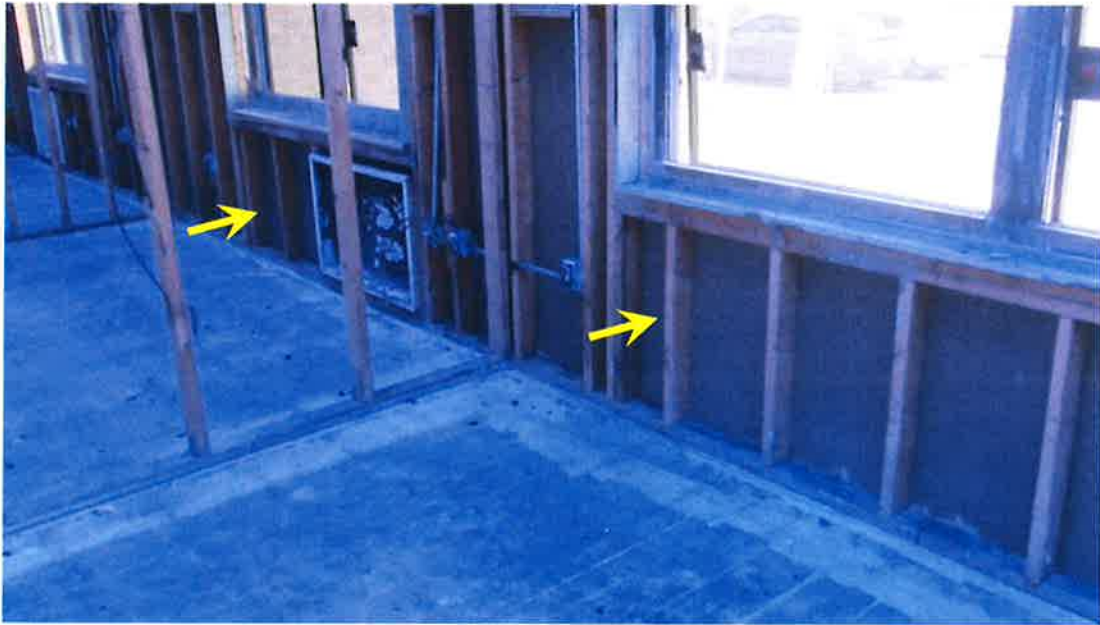
Photograph 45) – Interior view of the lower portion of the front exterior load-bearing wall framing at Unit #21 and #22. No repairs required.

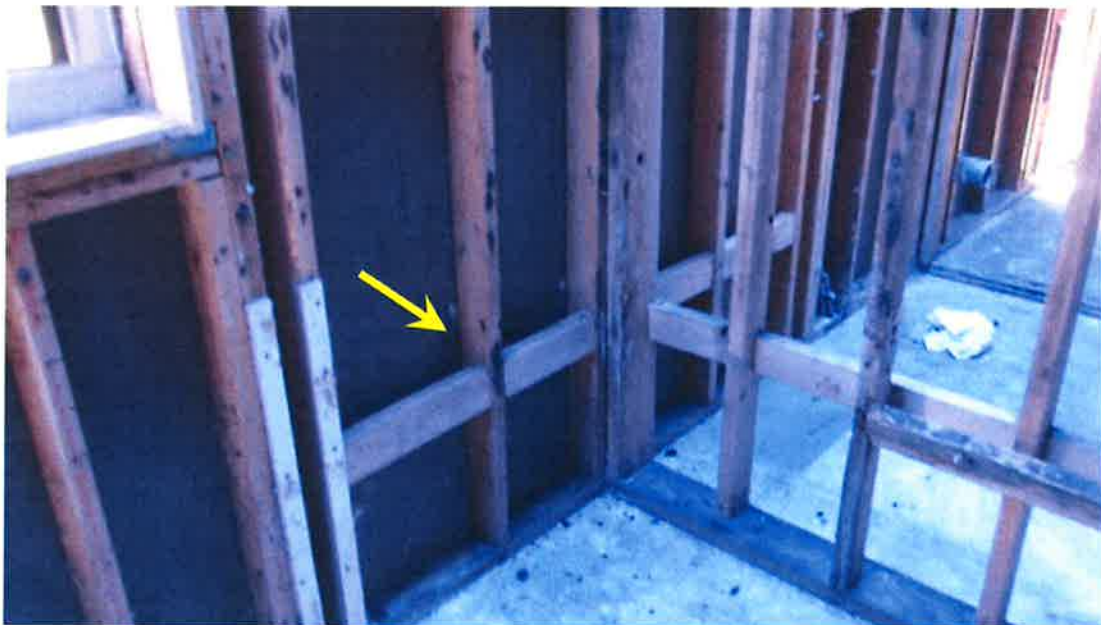
Photograph 46) – Interior view of the lower portion of the rear exterior load-bearing wall framing at Unit #22. No repairs required.

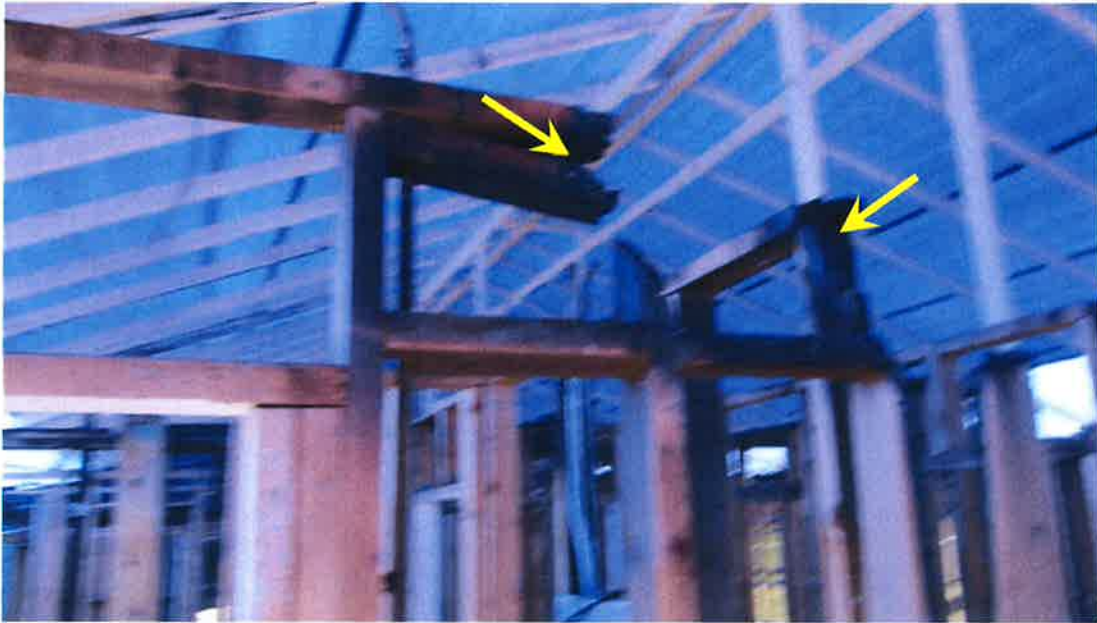
Photograph 47) – View of the upper portion of an interior partition wall in Unit #21 with fire-related damage requiring replacement.

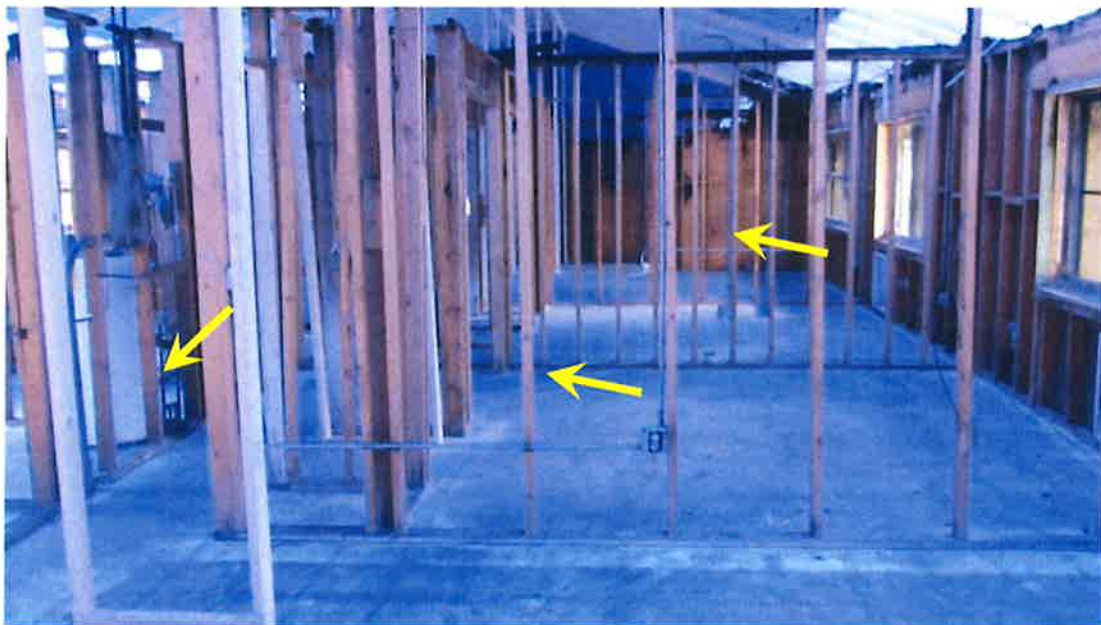
Photograph 48) – View looking north at the lower portion of interior partition walls in Units #21 and #22. No repairs required.

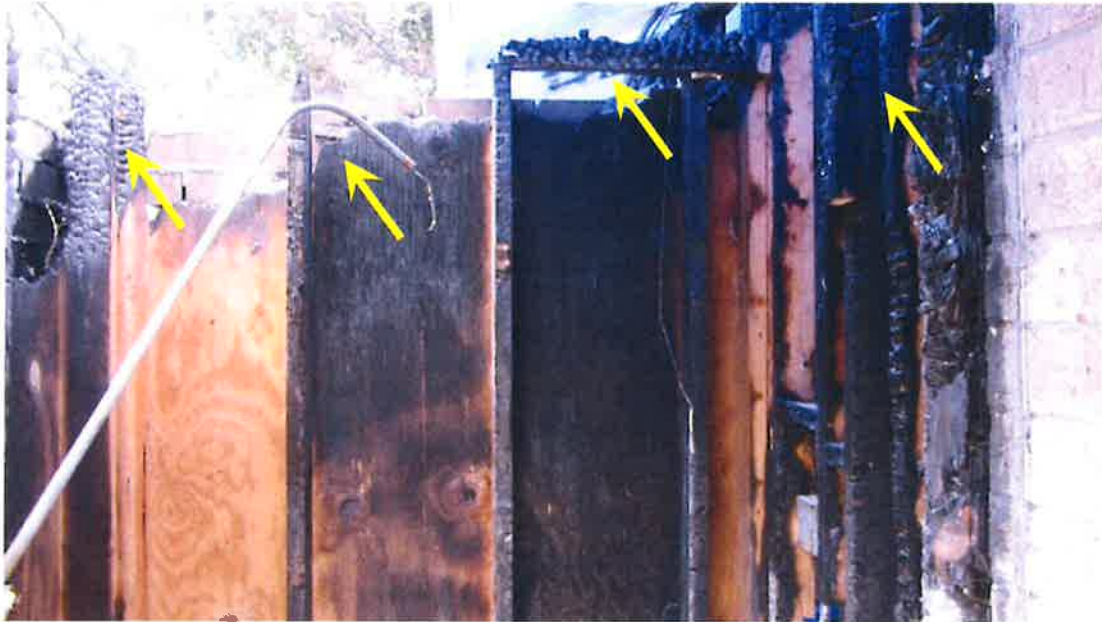
Photographs 49 through 55 show views of the exterior utility closet at the rear of Units #21 and #22. The upper portion of the exterior wood wall framing systems sustained severe fire-related damage and requires replacement of the 2x4 wood studs and the plywood sheathing. No fire-related damage to the 2x4 bottom plates were observed and can remain in place.

Photograph 49) – View looking north at the exterior utility closet at the rear of Unit #21. Arrows indicate fire-related damage to the upper portion of the wall framing system requiring replacement.

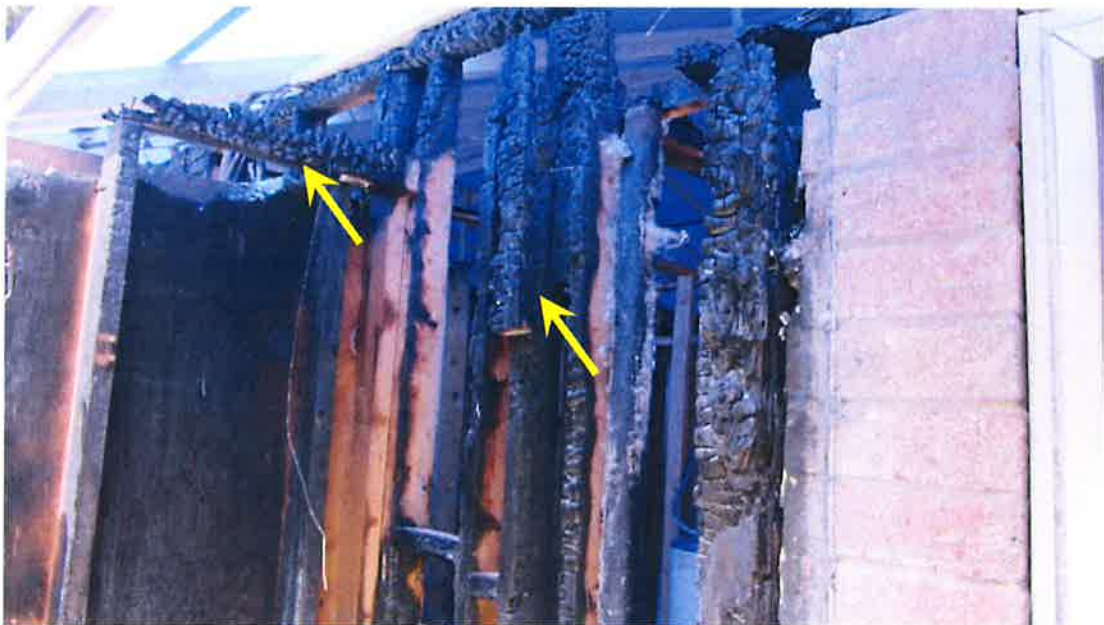
Photograph 50) – View looking northeast at the exterior utility closet at the rear of Unit #21. Arrows indicate fire-related damage to the upper portion of the wall framing system requiring replacement.

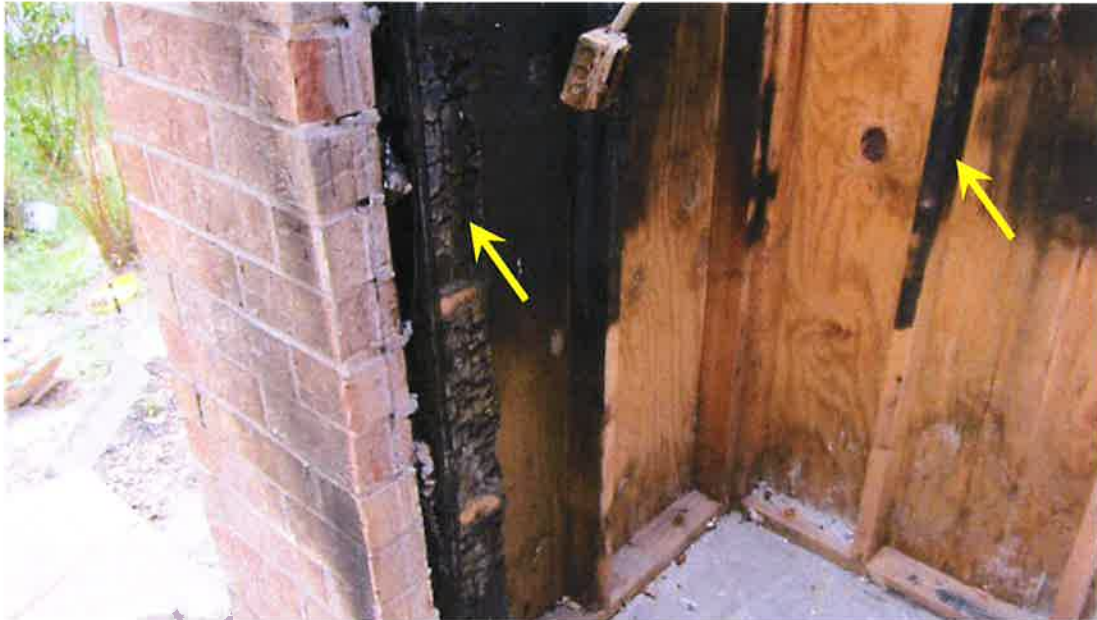
Photograph 51) – View looking northwest at the exterior utility closet at the rear of Unit #21. Arrows indicate fire-related damage to the upper portion of the wall framing system requiring replacement.

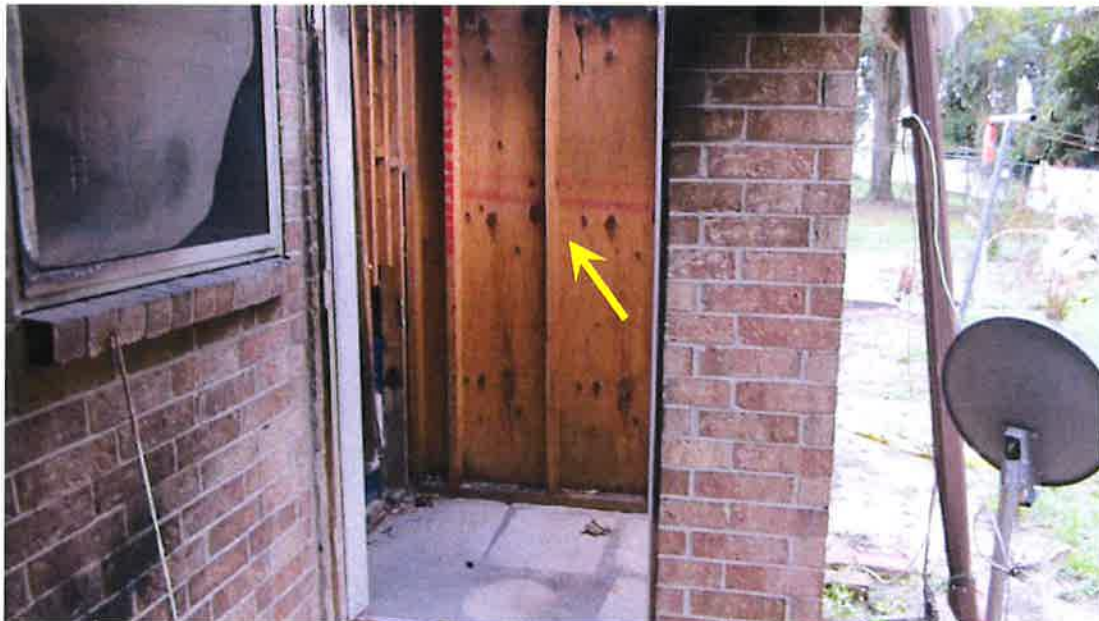
Photograph 52) – View looking south at the exterior utility closet at the rear of Unit #22. Arrows indicate the lower portion of the wall framing system with no fire-related effects or damage.

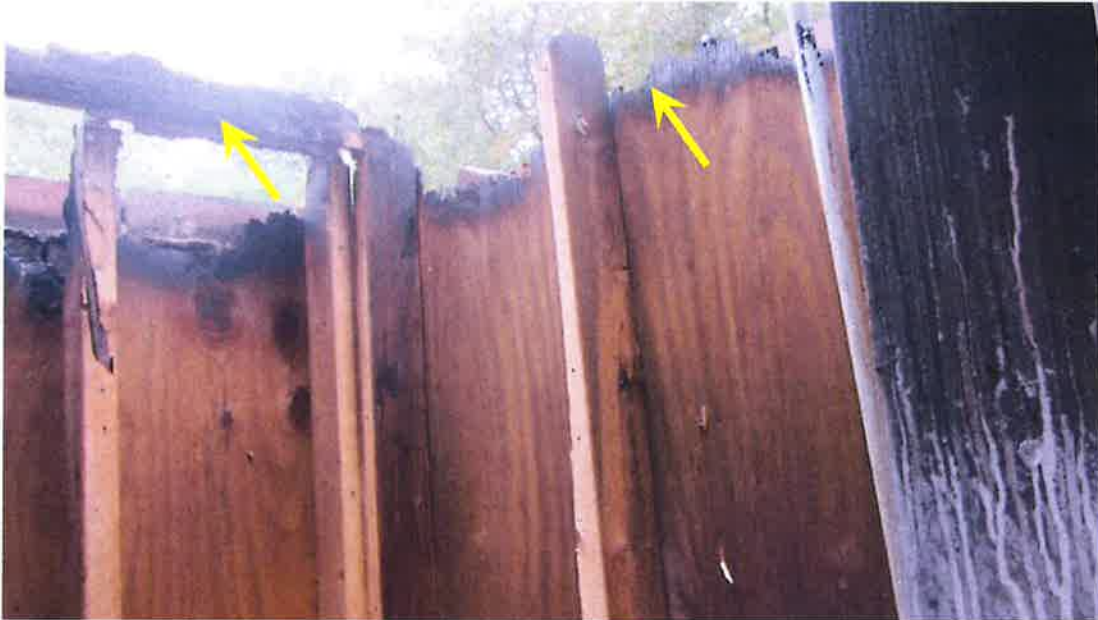
Photograph 53) – View looking southwest at the exterior utility closet at the rear of Unit #22. Arrows indicate fire-related damage to the upper portion of the wall framing system requiring replacement.

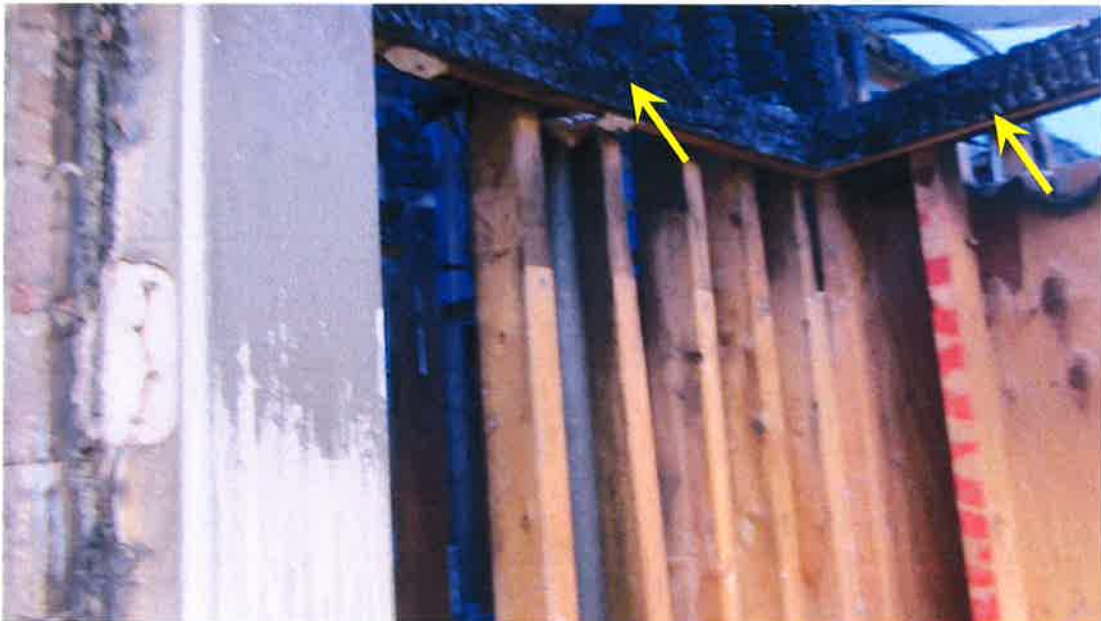
Photograph 54) – View looking southeast at the exterior utility closet at the rear of Unit #22. Arrows indicate fire-related damage to the upper portion of the wall framing system requiring replacement.

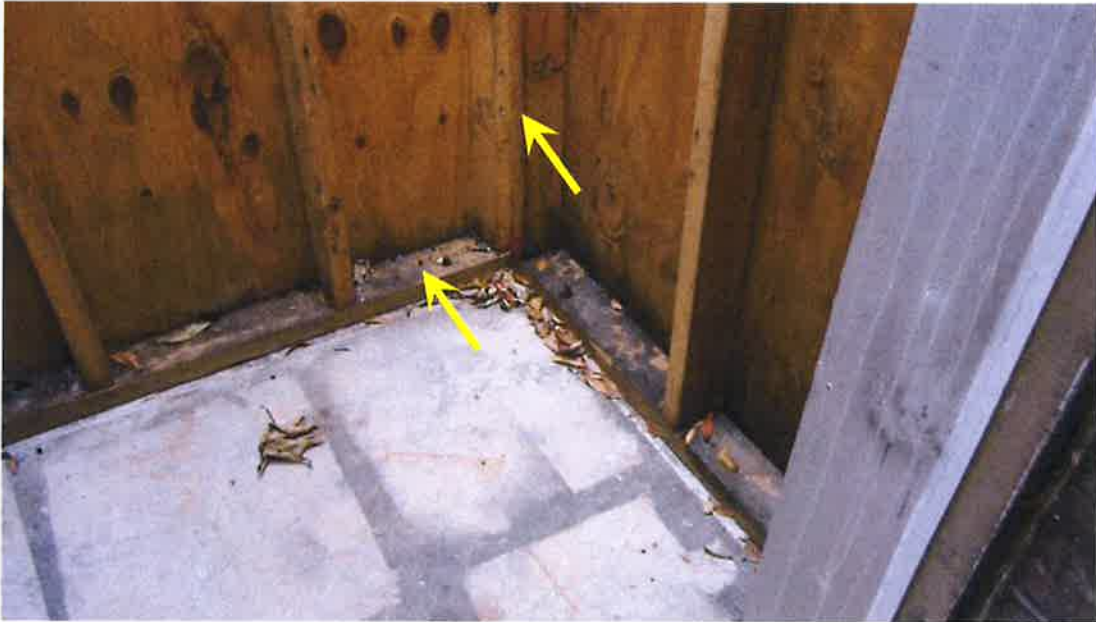
Photograph 55) – View looking at the exterior utility closet at the rear of Unit #22. Arrows indicate the lower portion of the wall framing system with no fire-related effects or damage.

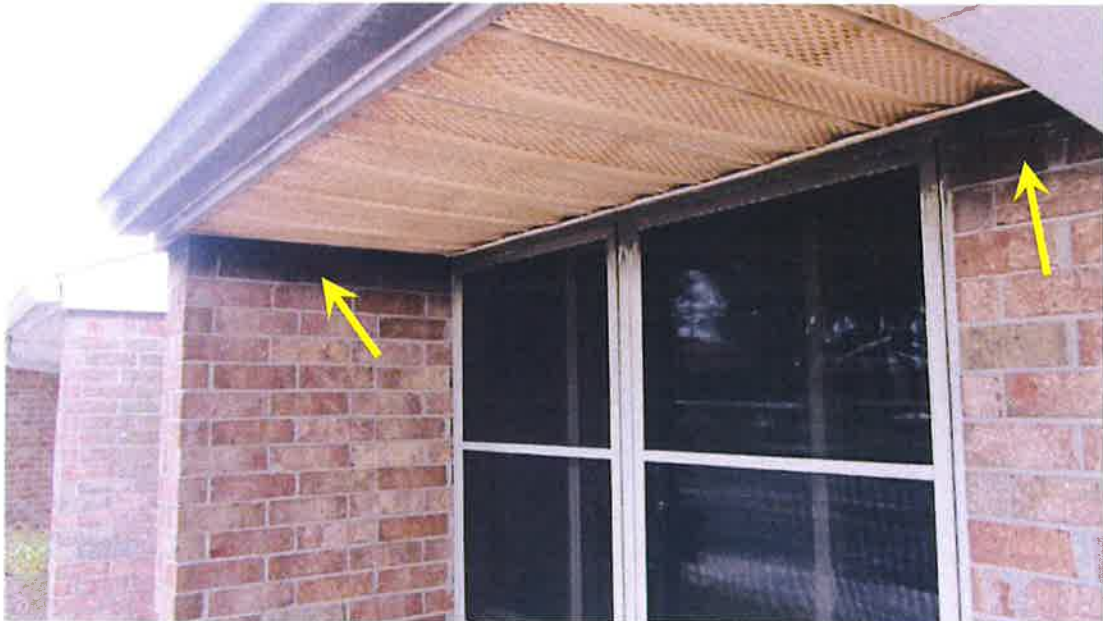
Photograph 56) – View of the exterior brick cladding. Fire-related effects from smoke shown with arrows.

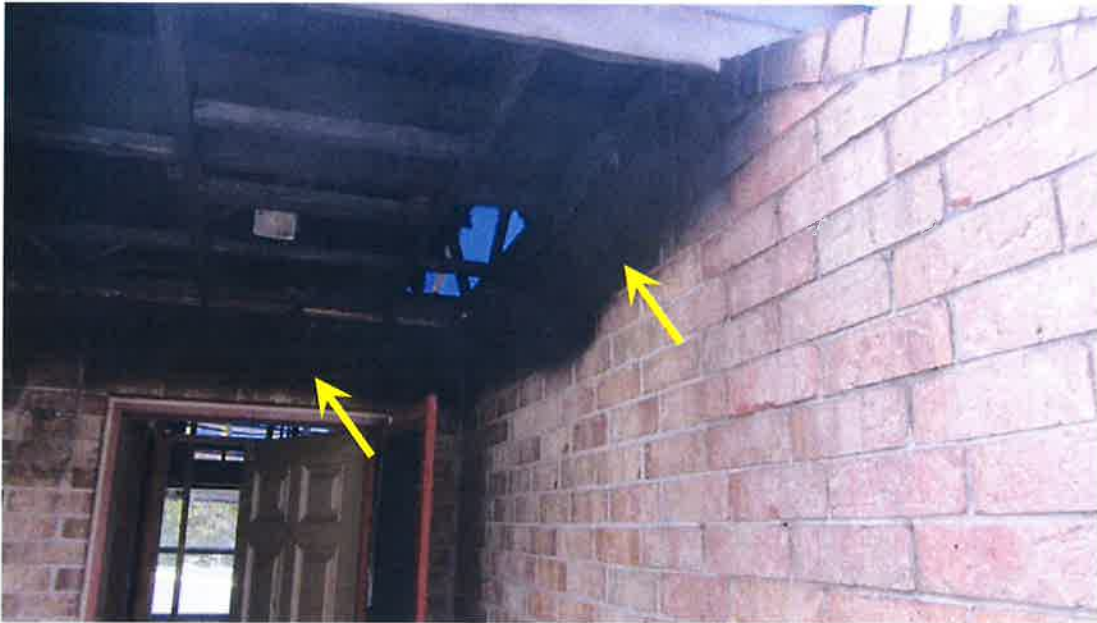
Photograph 57) – View of the exterior brick cladding at the front entry foyer of Unit #21. Fire-related effects from smoke shown with arrows.

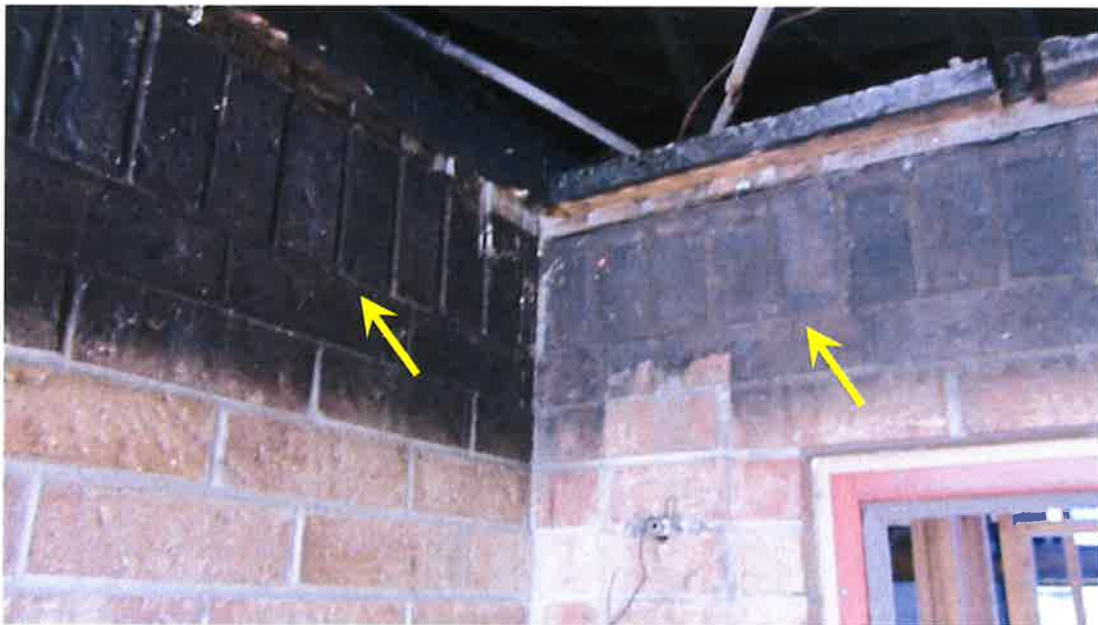
Photograph 58) – Close-up view of the exterior brick cladding at the front entry foyer of Unit #21. Fire-related effects from smoke shown with arrows.

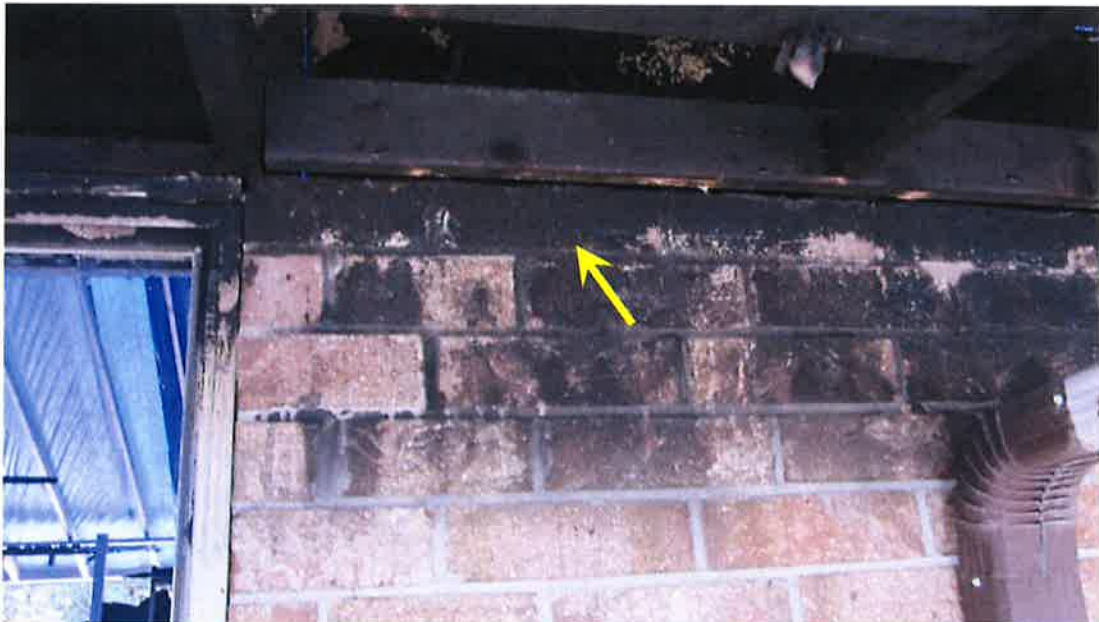
Photograph 59) – View of the exterior brick cladding at the rear exterior wall of Unit #21. Fire-related effects from smoke shown with arrows.
