INVITATION FOR BIDS
Structural Repairs and Replacement Construction at Cecil Gober
Villas Apartments Units #19-20-21-22

The Housing Authority of the City of Lakeland (herein referred to as "*LHA*") hereby requests bids from licensed and qualified contractors for the repair of fire damage to Units 19, 20, 21, 22 of Cecil Gober Villas Apartments. The repairs must result in the unit being in an *equal to* or *better than* condition than existed prior to the damage. The Scope of Work generated by the insurance adjuster is attached herein as *Exhibit "A"*.

As requested, Jesse W. Curtis, P.E., a FORCON International Corporation (FORCON) Consultant and Professional Civil/Structural Engineer, performed a site investigation and evaluation of reported fire damage at the subject property. The site investigation was performed on June 21, 2021. Mr. Bert McFarlane, representing the insured, provided access to the exterior, interior, and roof of the subject property. The purpose of the investigation was to evaluate the alleged fire damage in the building containing four dwelling units. **FORCON's scope included a structural evaluation of the interior and exterior building to identify building e

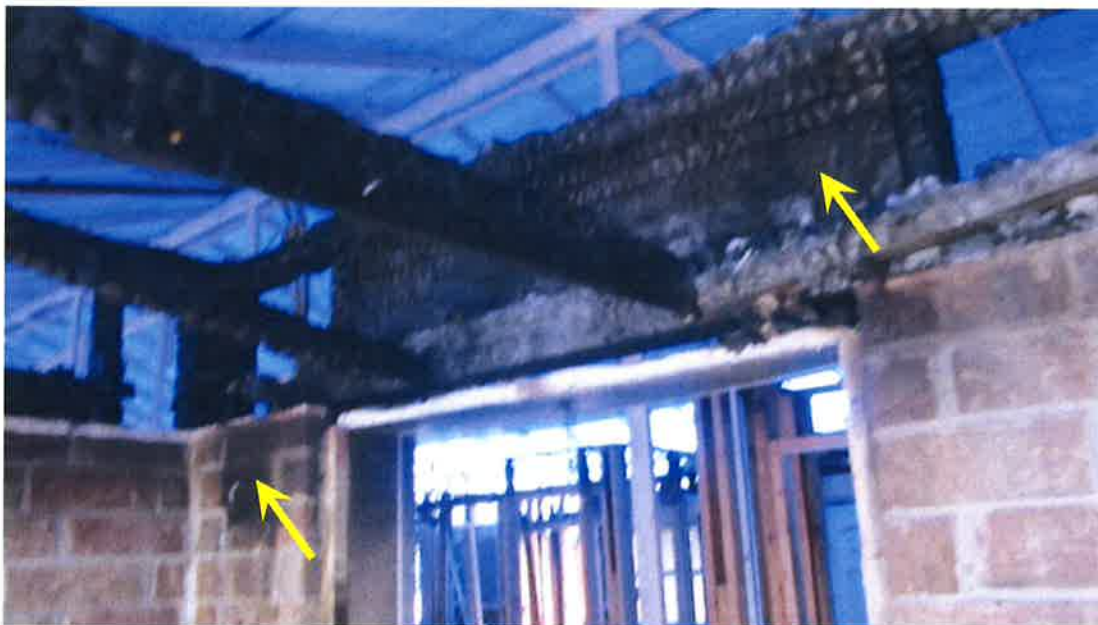
Photograph 60) – View of the exterior brick cladding at the front entry foyer of Unit #22. Fire-related effects from smoke shown with arrows.

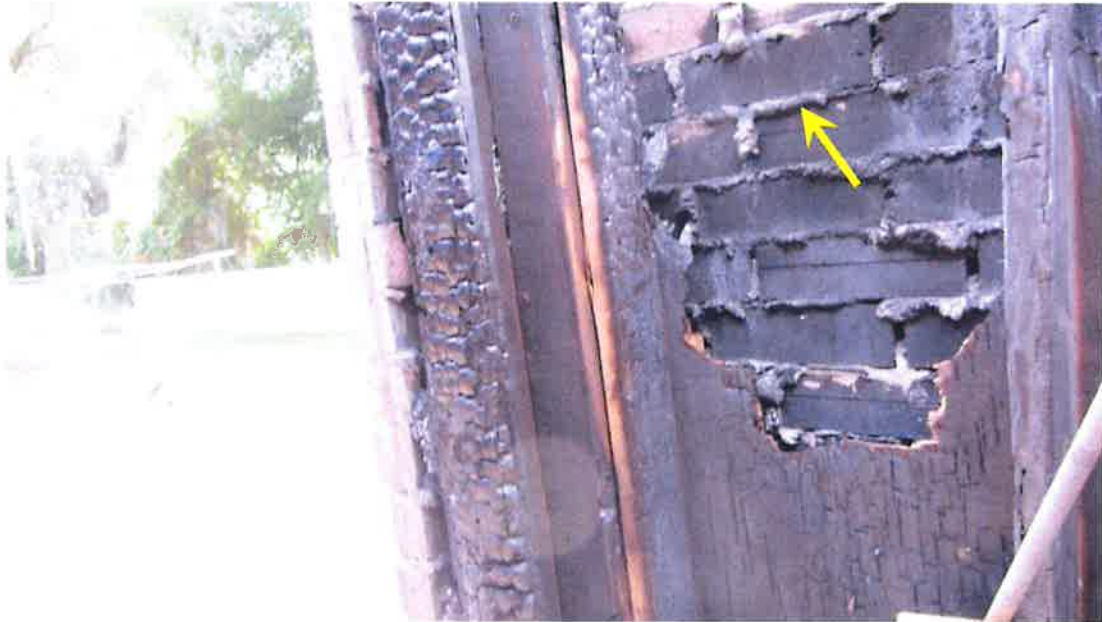
Photograph 61) – Close-up view of the rear exterior utility closet at Unit #21. Arrow indicates backside of brick cladding with fire-related effects. No repair required.

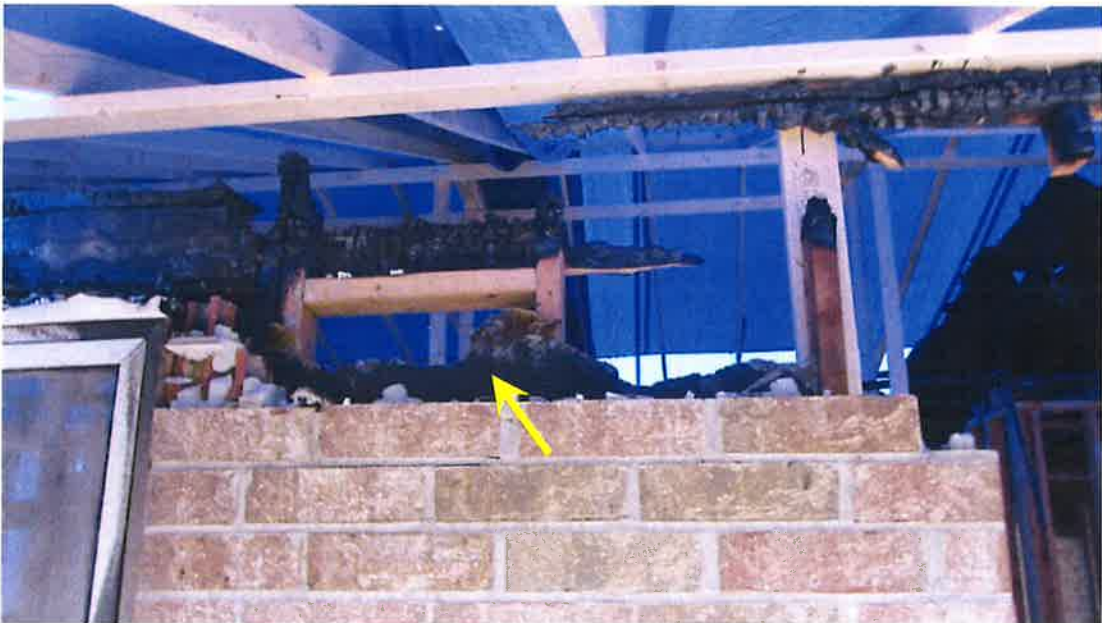
Photograph 62) – View looking east at the rear exterior brick cladding at Unit #21. Repair of missing brick required.

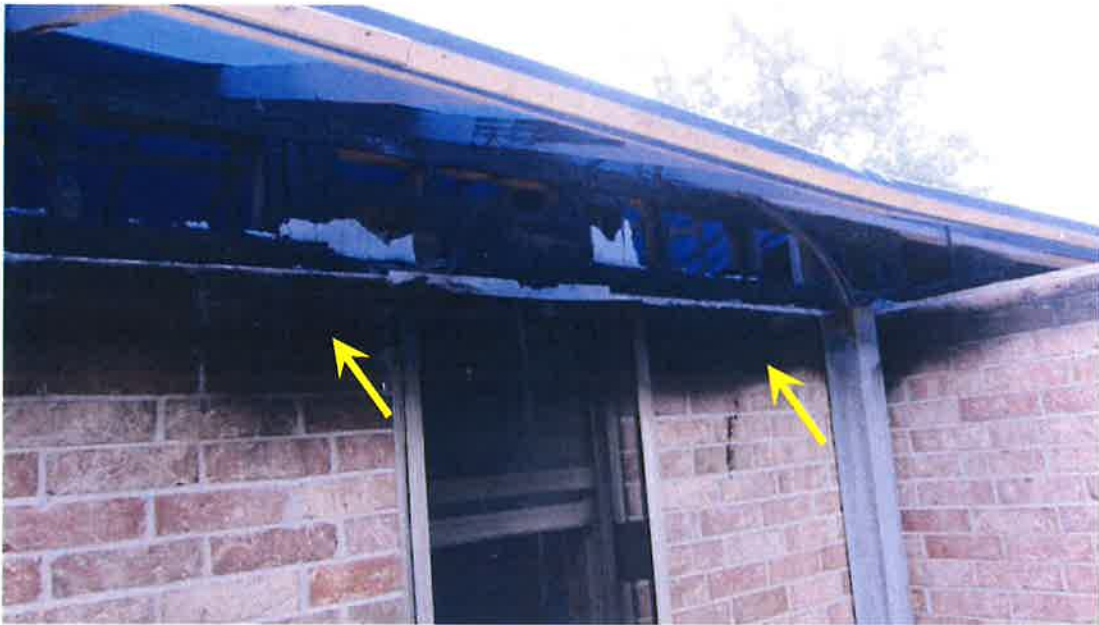
Photograph 63) – View of the exterior brick cladding at the rear of Unit #22. Fire-related effects from smoke shown with arrows.

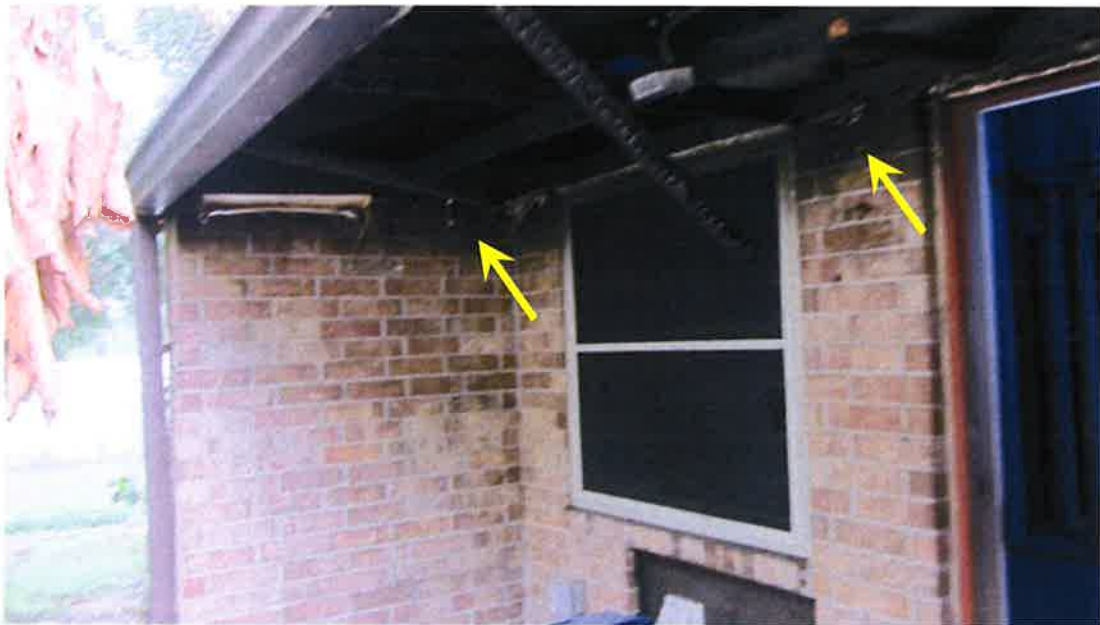
Photograph 64) – View of the exterior brick cladding at the rear of Unit #22. Fire-related effects from smoke shown with arrows.
